FLAGS PIPELINE IN-LINE INSPECTION

PPSA 08/11/17

FLAGS (Far North Liquids and Associated Gas) pipeline system

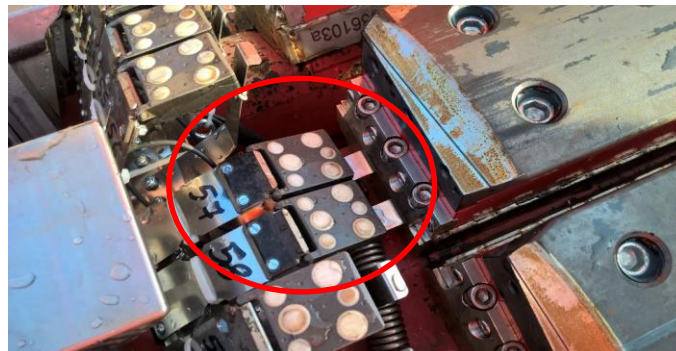
FAT – MFL SIDE FLOW TEST RESULTS

- Passage of both tools with side flow of 300 L/s water @ ~1 cm/s
 $E \propto mv^2, v_g = 2.87 \times v_w$
for 16" side port, $v_w = 2.1$ m/s, $v_g = 6$ m/s
for 6" side port, $v_w = 15$ m/s, $v_g = 43$ m/s
- Acceptance criteria:
 - The foreseen acceptance criterion is two consecutive instrument passages without functional damage.
- Results:
 - Two sensors at the 12:00 position found to be "clicked into" a gap underneath the magnets.
 - Consequence during actual run would be loss of these two sensors

ROSEN determined this as a design flaw and re-positioned the sensor ring to eliminate this problem. Subsequent test proved this design to be optimal.

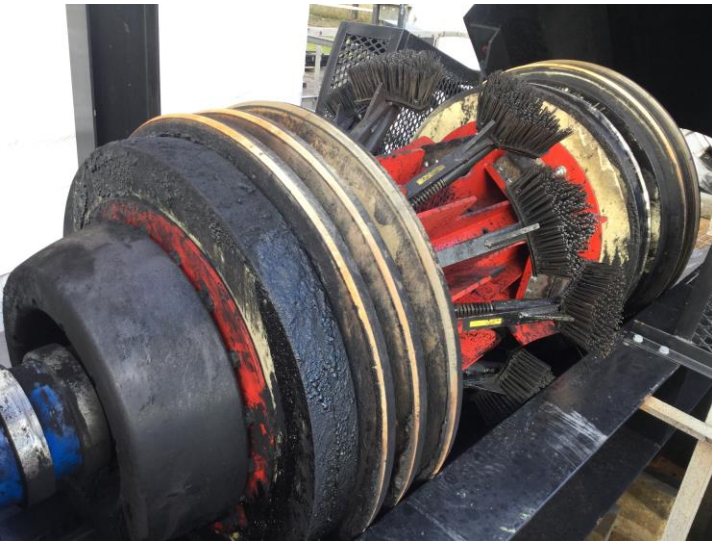
Cleaning pig

- Overall tool condition good upon receive
- Tool removed minimal dust / ferrous debris
- Gauge plate had a small deflection of 2mm likely to be caused by mechanical pig signaller
- No further cleaning / gauging runs were required prior to MFL tool

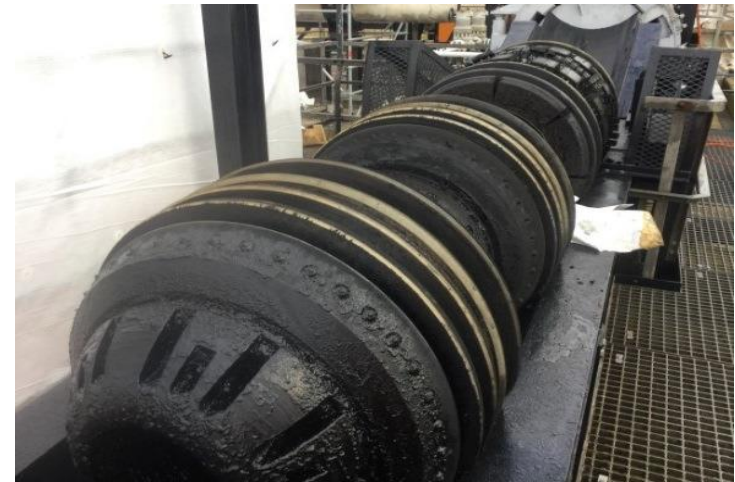
MFL pig

- Tool in good condition upon receive
- Ferrous material collected on magnets upon recovery
- Minimal wear to front seals
- Sludge type debris received in front of tool
- In-line inspection (ILI) data acceptance criteria was met
- ILI final report received with presence of no significant internal corrosion
