High Paraffin Content and Long Distance – A Particular Challenge for Cleaning and Inspection of a Crude Oil Pipeline

Felix Schmidt, 3P Services
Antoine Etouge, Total E&P Gabon

Project Introduction

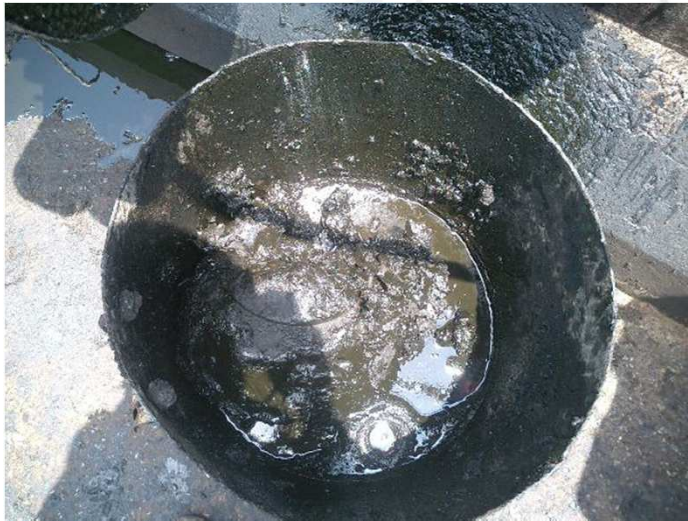
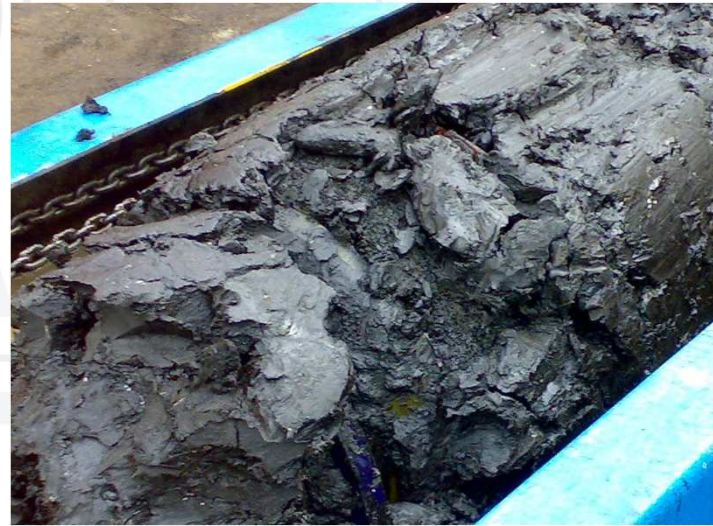
- Pipeline Cleanliness:
 - Experience from last inspection
 - small volume of soft paraffin during cleaning
 - large volume of hard paraffin plugged the inspection tool

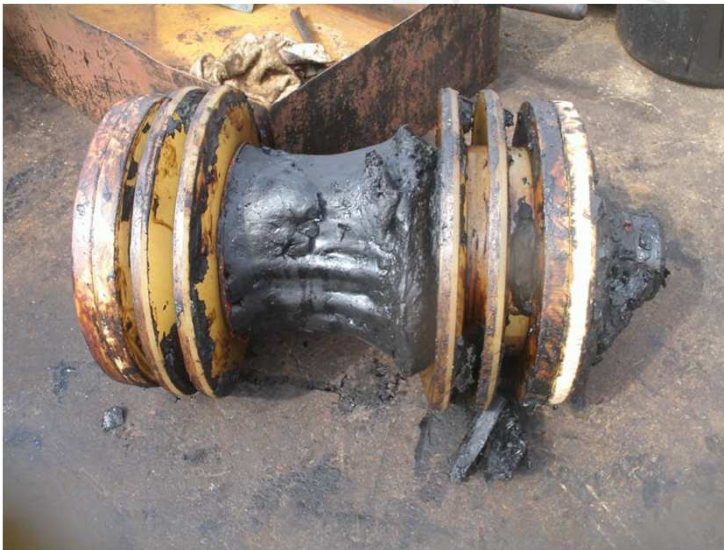
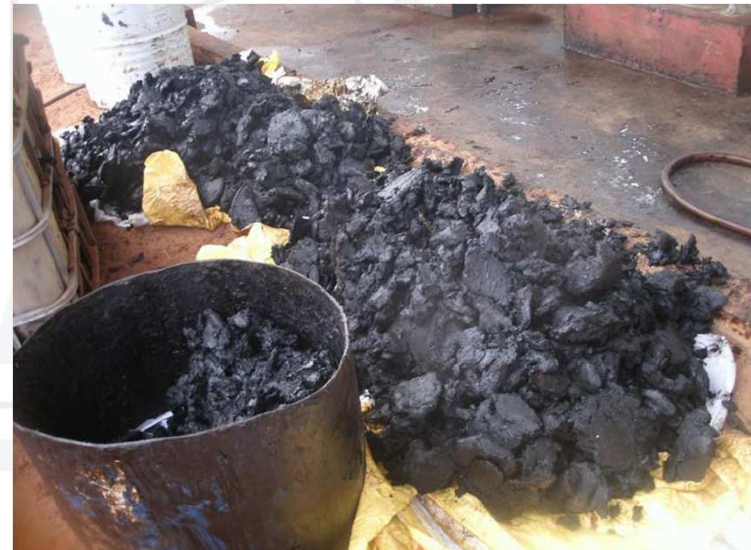
- Pipeline Cleanliness:
 - Experience from bidi cleaners
 - sometimes 20-50kg, sometimes hundreds of kg
 - consistency varies from soft to hard paraffin

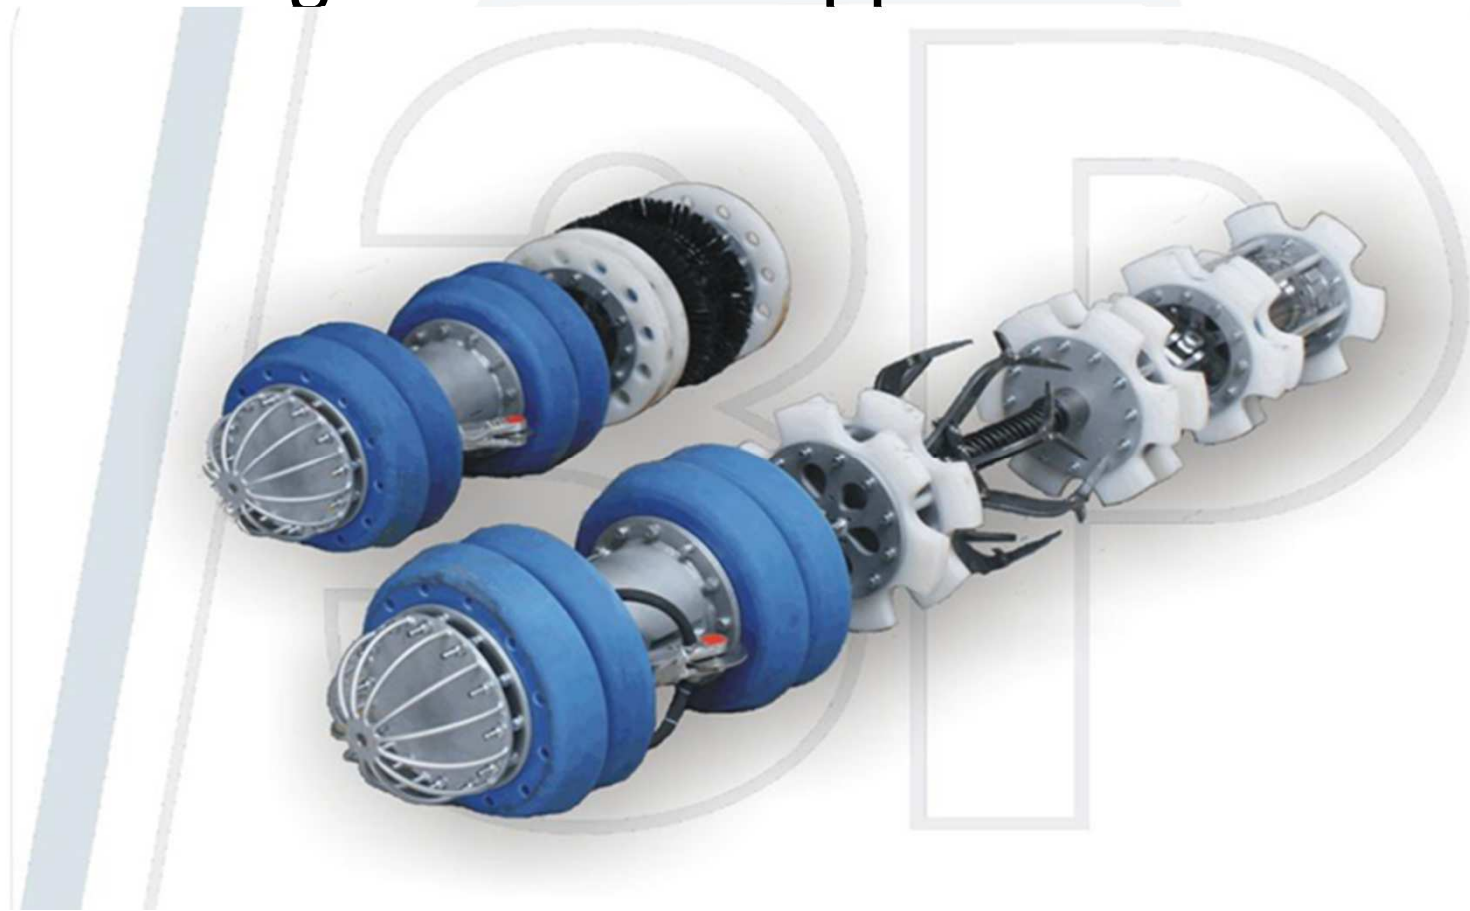
- Cleaning tools to be applied:

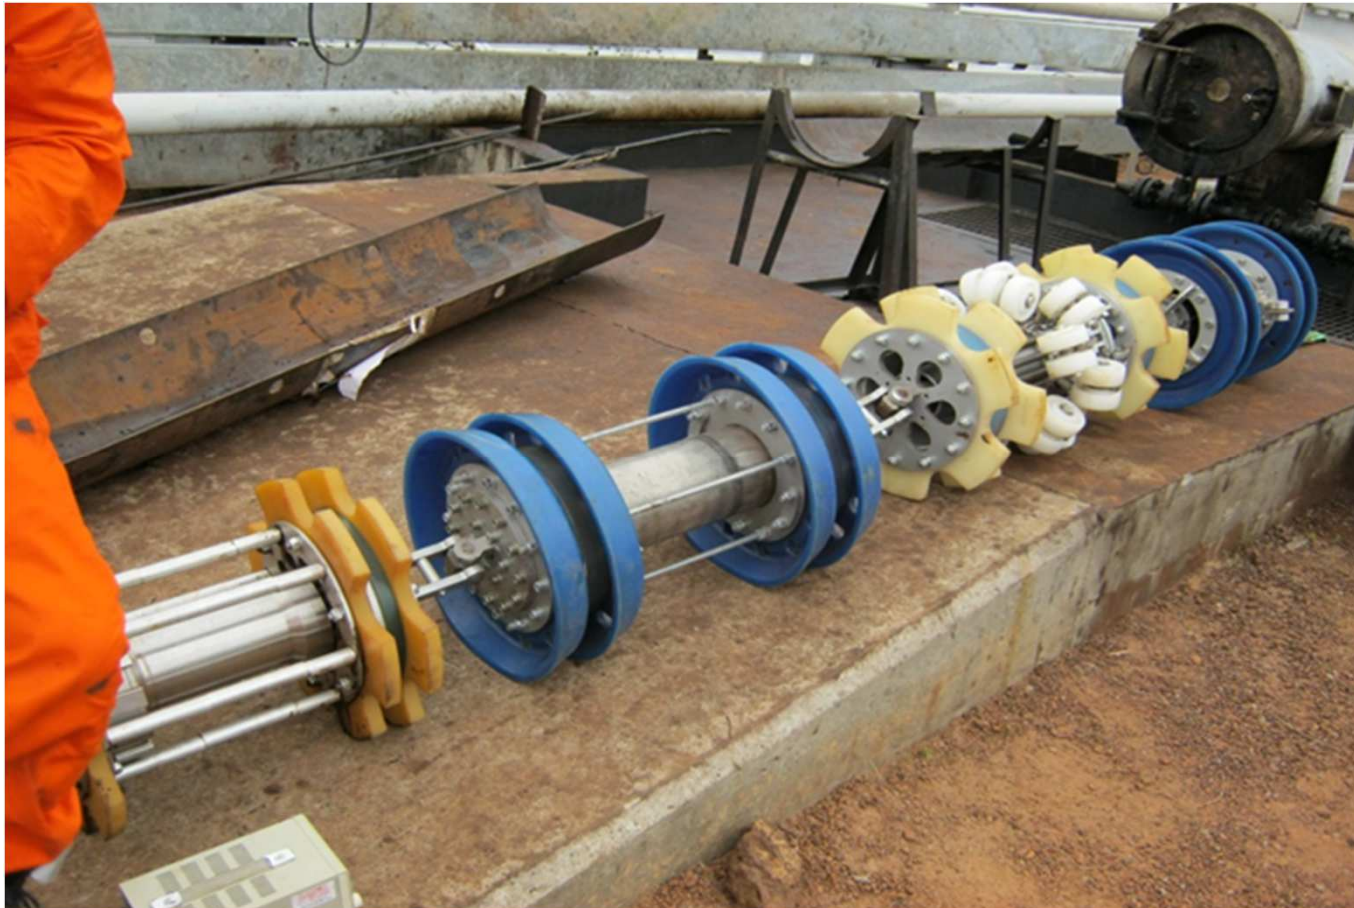
Picture: GEO+ tool applied

- Inspection tools to be applied:
- GEO+:
 - combination of GEO and DMR sensors
 - measures internal diameter
 - distinguishes between paraffin and metal
- → provides high value information on cleanliness of the line

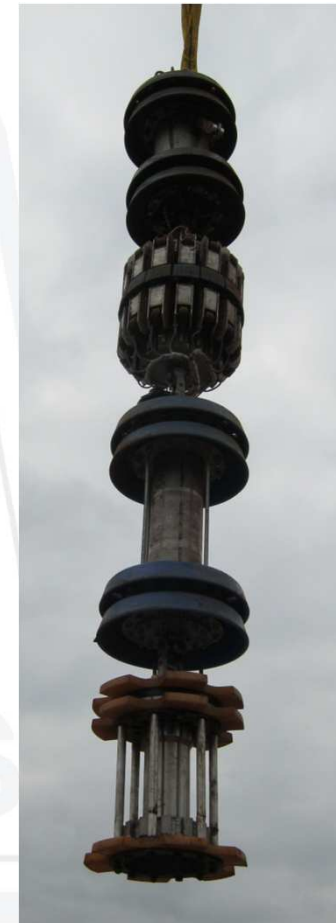
- Inspection tools to be applied:
- MFL:
 - high resolution MFL tool
 - very long battery life time (>6 days)
 - high „paraffin resistance“ package

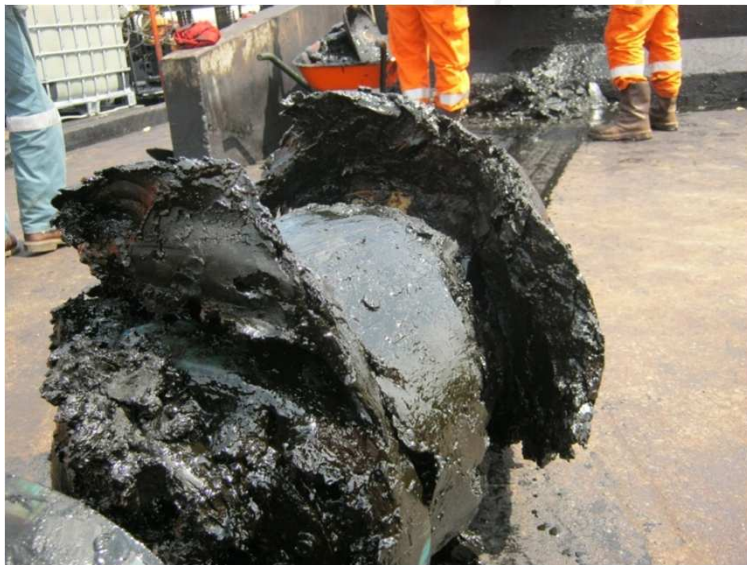
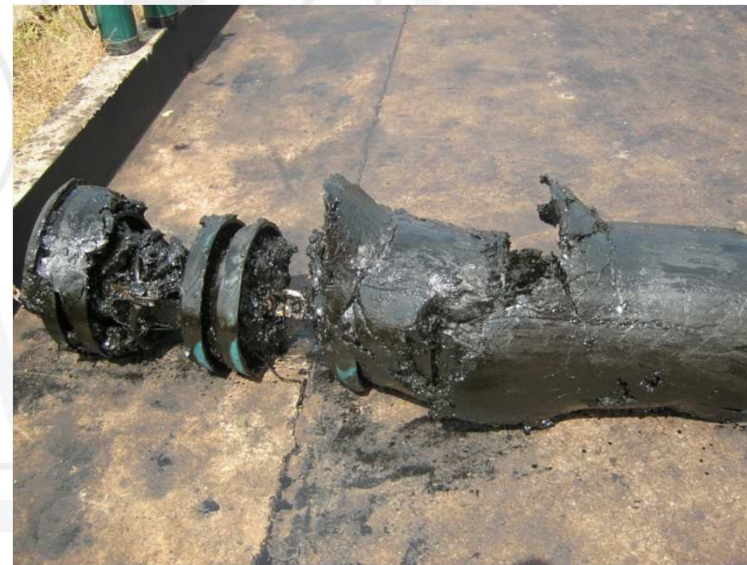
- after months of TEPG cleaning, 3P mobilised engineers, profile pig and GEO+
- profile pig run received with 100kg paraffin

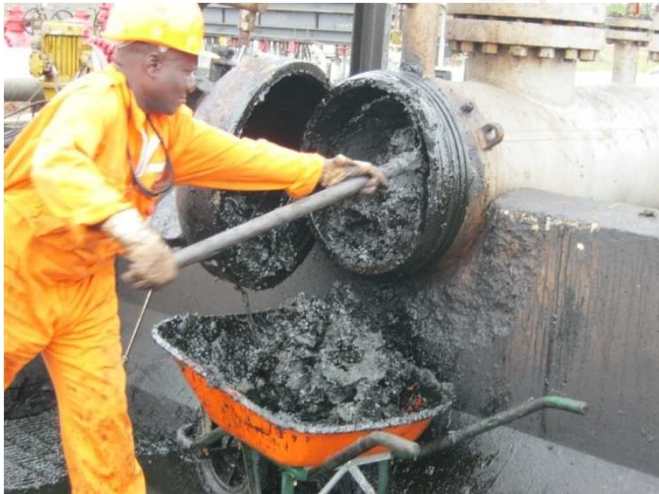
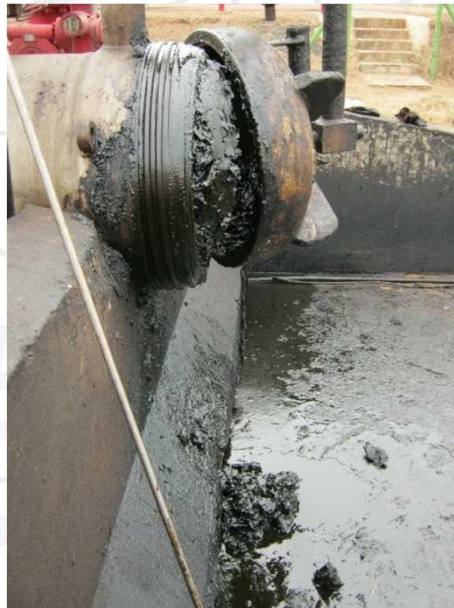
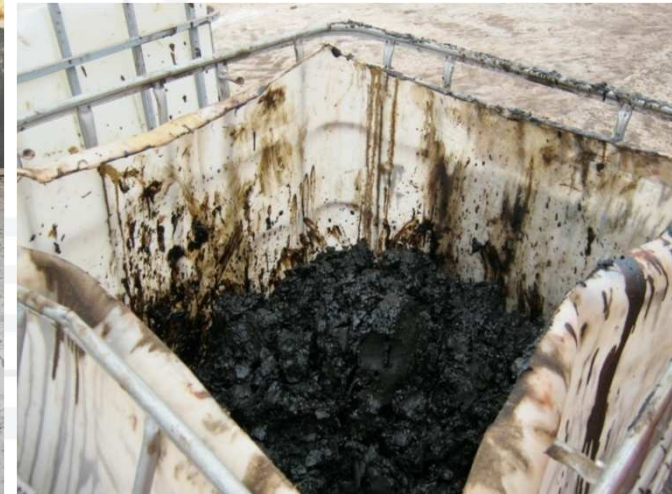
- further cleaning pig runs with multiple pigs in the line
- → approx. 500kg of paraffin has still been removed

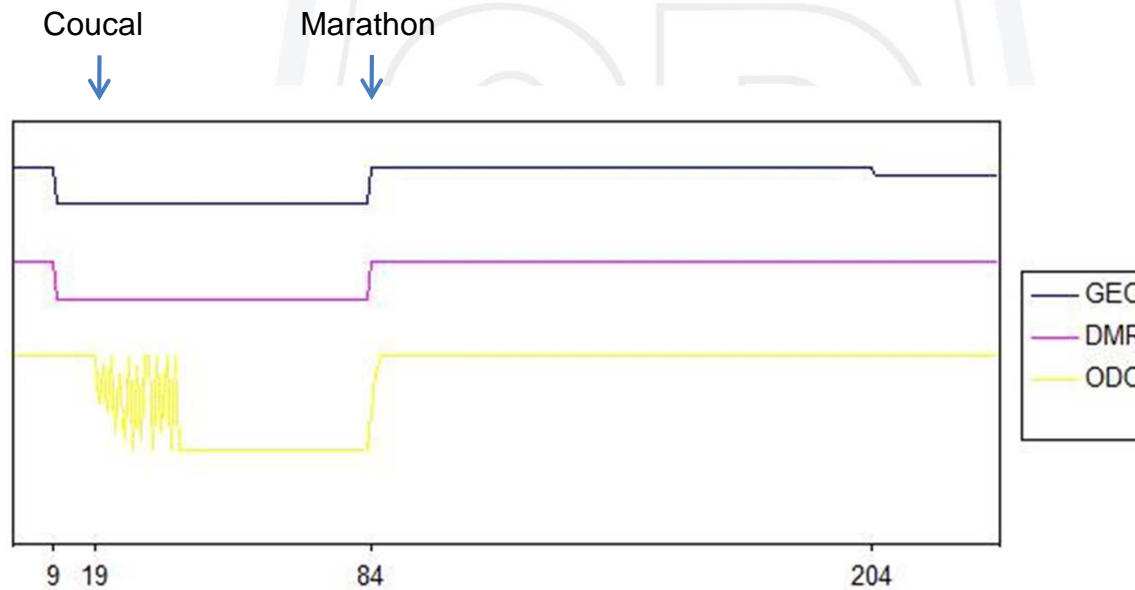
- Results of GEO+ inspection:

- Results of GEO+ inspection:
 - no critical restrictions, but data degradation likely
 - paraffin issues locally restricted
 - good chance that MFL tool will recover behind Marathon Tee
- → decision was taken to go for the MFL instead of doing further cleaning activities

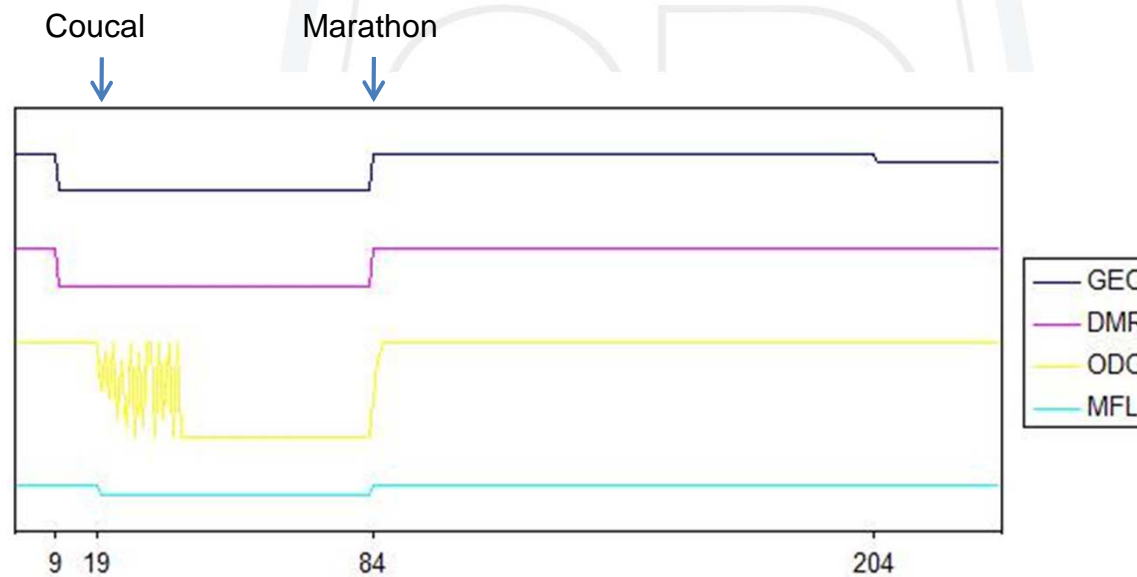
- Results of MFL inspection:

- Results of MFL inspection:
 - odometer slippage between Coucal and Marathon
 - → was aligned to 2003 distance measurement
 - only minor data degradation between Coucal and Marathon
 - correction factor was calculated for paraffin influence
 - several defects could already be verified which confirmed the results of the inspection
