Magnetic eddy current as a novel technique for the internal inspection of CRA-lined pipe

*PPSA Seminar November 18th 2015, The Ardoe Hotel,
Aberdeen*

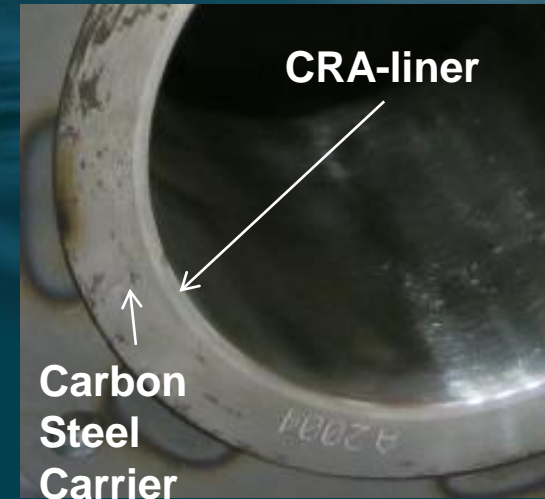
What are clad and lined pipes?

- **Clad pipe:**
 - **Metallurgically clad by**
 - » **Roll bonding**
 - » **Explosion bonding**
 - » **Overlay welding**
 - **Resulting in a metallic bonding between carrier pipe and CRA pipe**
- **Lined Pipe:**
 - **CRA pipe is expanded inside a carrier pipe. Pipe ends are made with overlay welding to ensure weldability.**
- **Typical Defects:**
 - **Many, but mainly internal corrosion of carrier pipe**

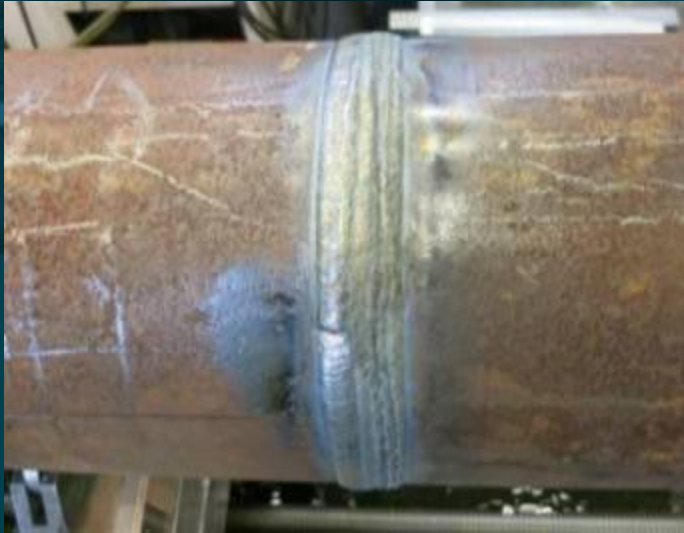
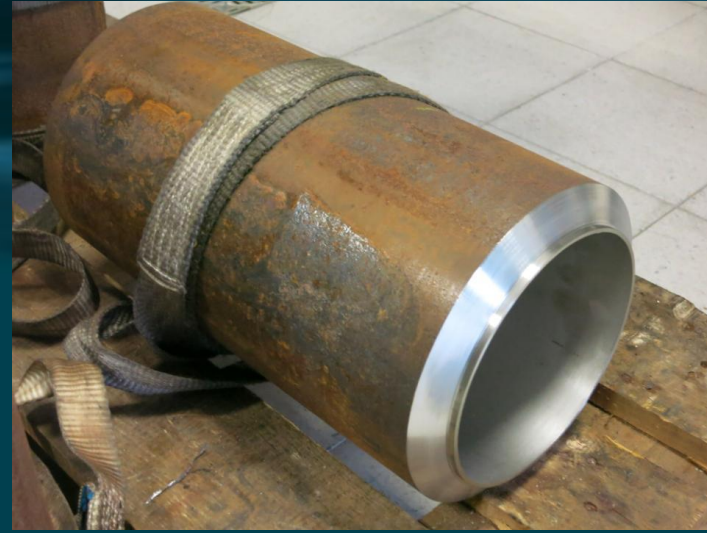
Test Pipe

Carbon Steel carrier pipe	CRA-liner
OD	8.625" (219 mm)	
ID		6.765" (171.8 mm)
Thickness	0.812" (20.6 mm)	0.118" (3 mm)
Material	X65	825 Incoloy
Pipe Type	Seamless	Long seam welded

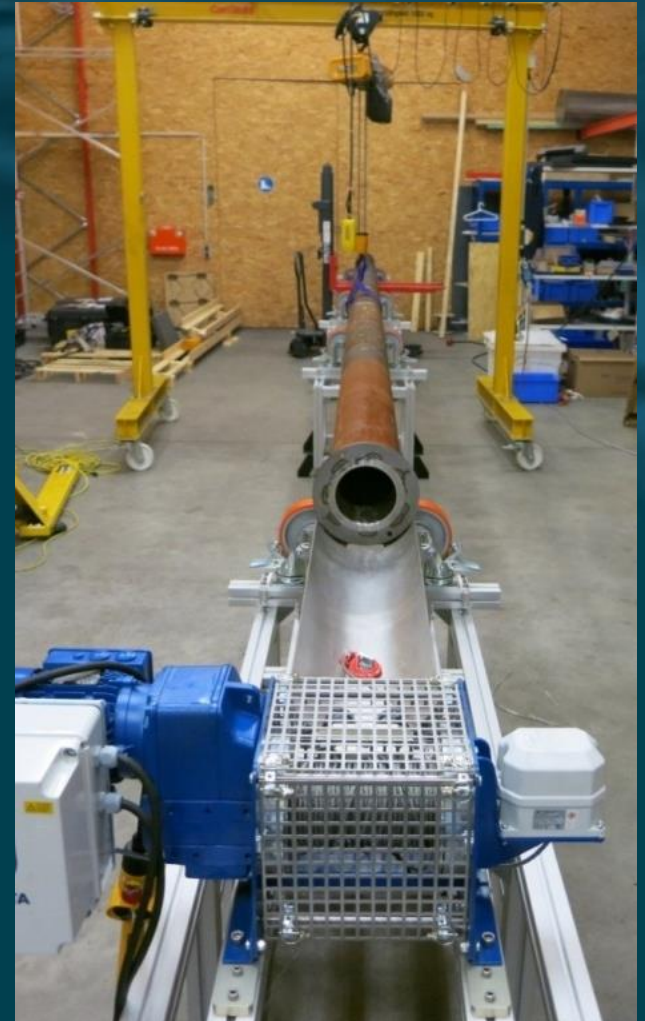
Prototype tool

Workshop set-up
for pull tests

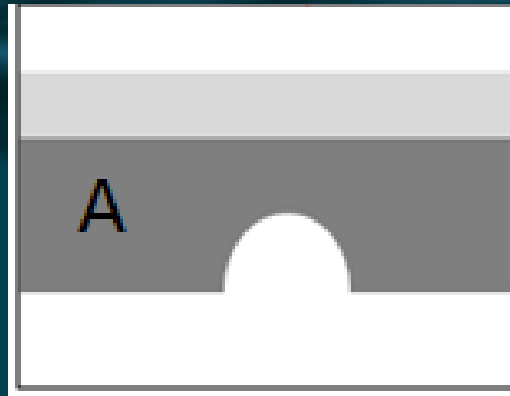
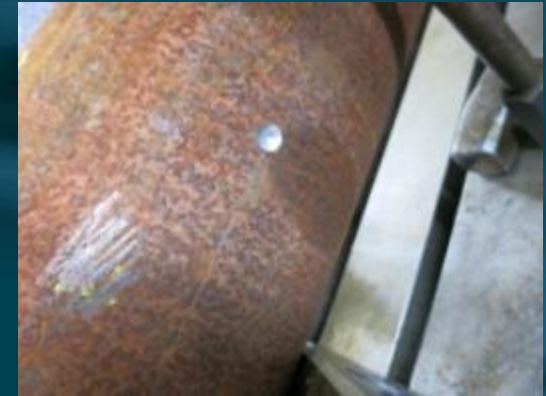
External metal loss

Depth:
20%-80% of carrier pipe
Size:
3mm – 24 mm diameter

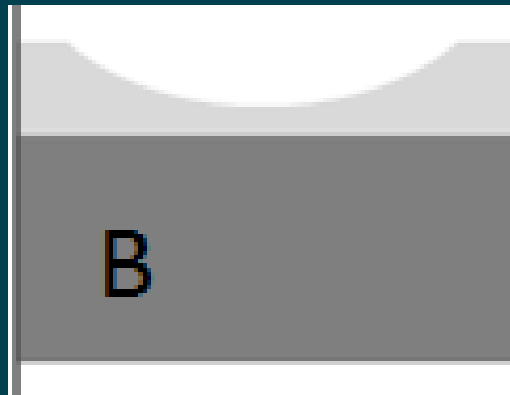
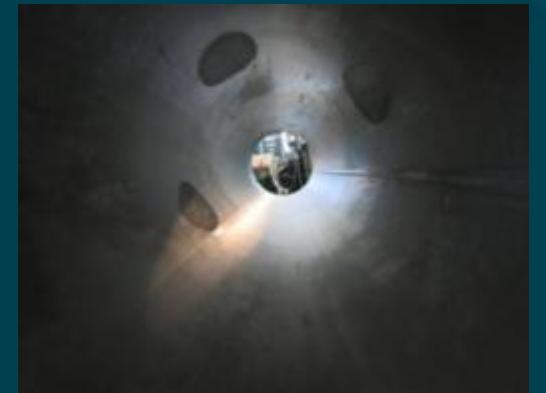
Internal erosion
20% to 60% of liner
50 x 100 mm

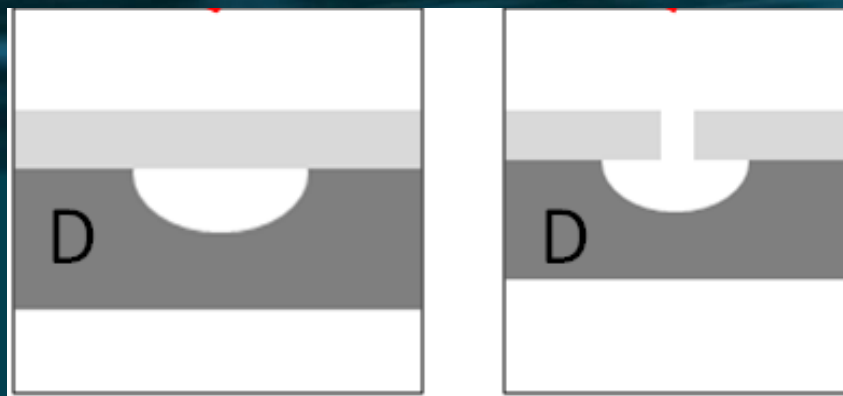
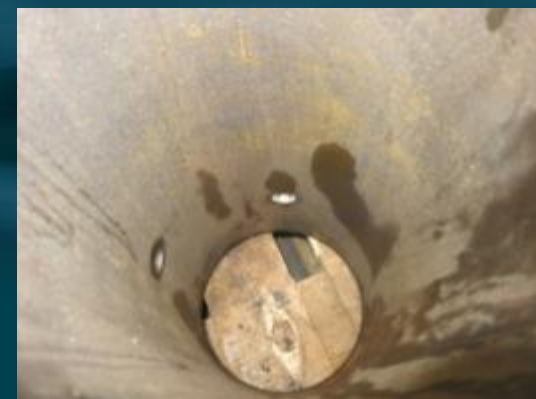
**Crevice
corrosion**
10%-50%
6-24mm

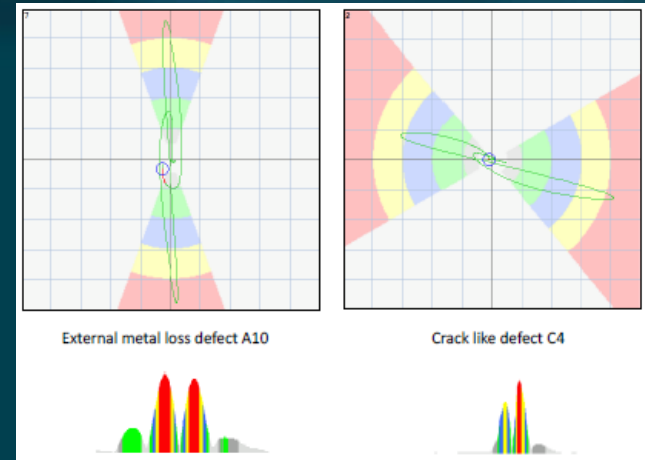
Display of data in form of Amplitude colour mapped C-Scans

- Display in impedance plane
- Amplitude time view
- Color mapped signals

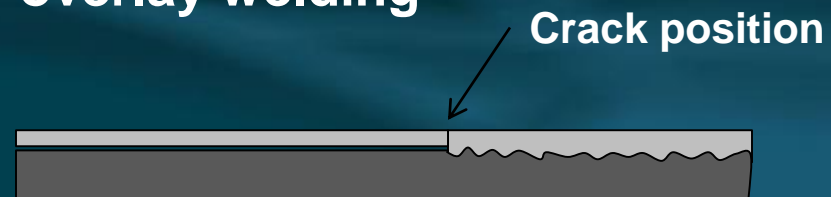
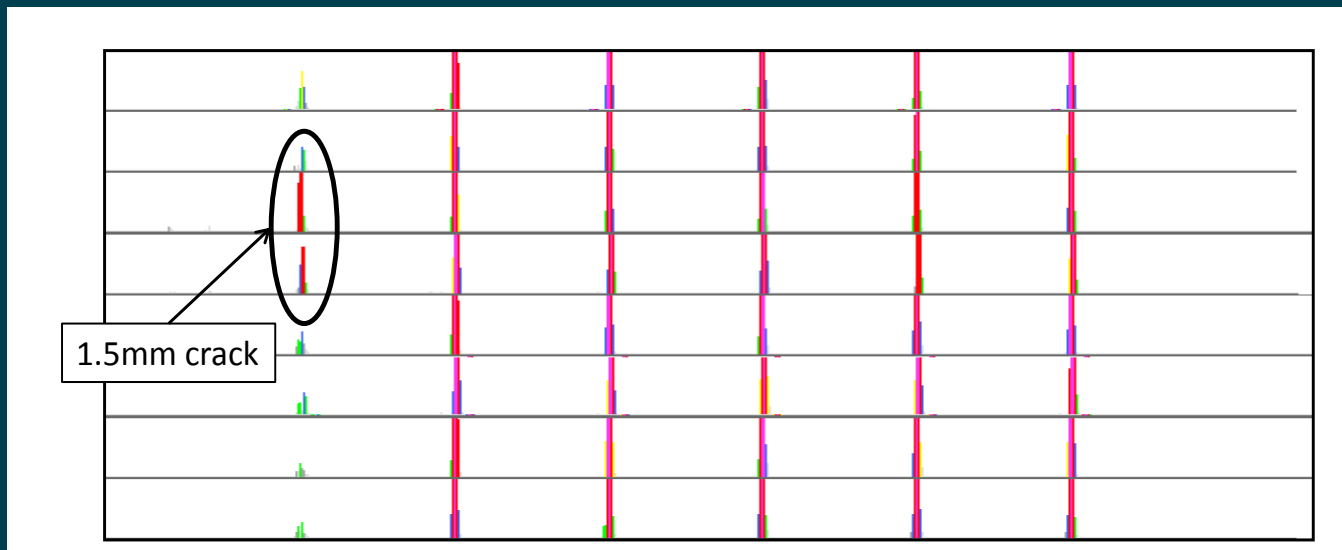
In base material
Potentially found at
interface from liner to
overlay welding

In a girth weld

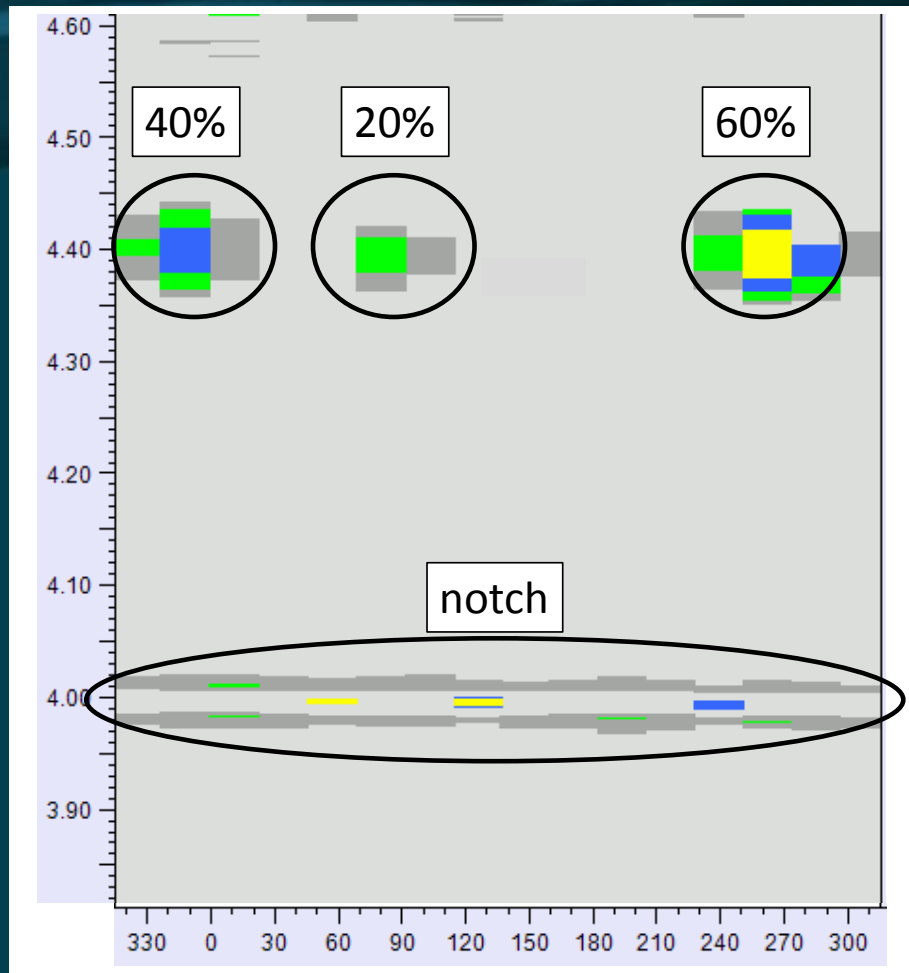
Erosion type defects

**Roughly linear relation
between signal amplitude
and depth**
