**World First Pressurised Subsea Pipeline Repair
Facilitated By A Combination Of
Non-Piggable And Piggable Isolation Tools**

PPSA Seminar 2016

Yacheng Pipeline Repair Case Study

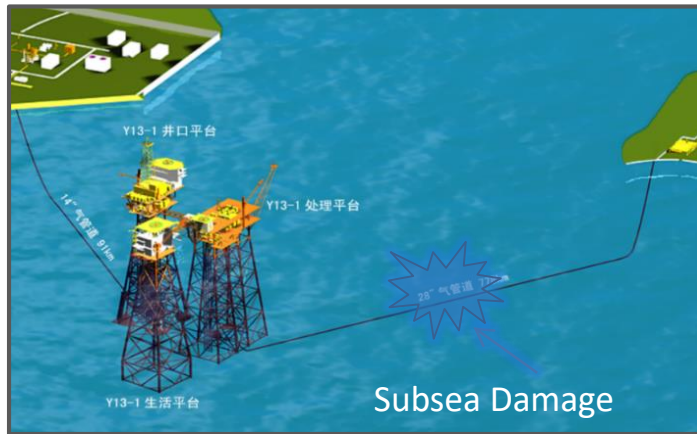
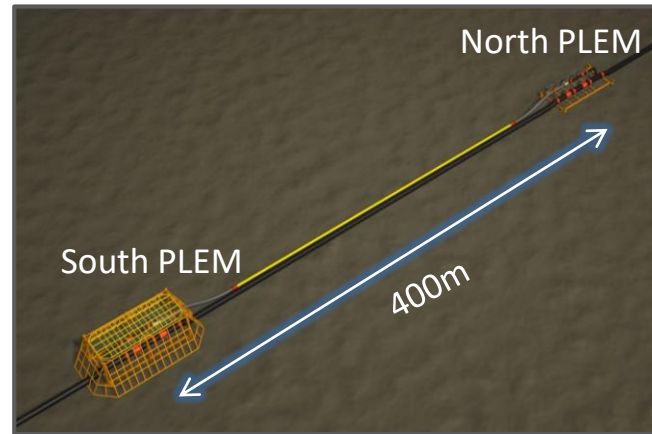
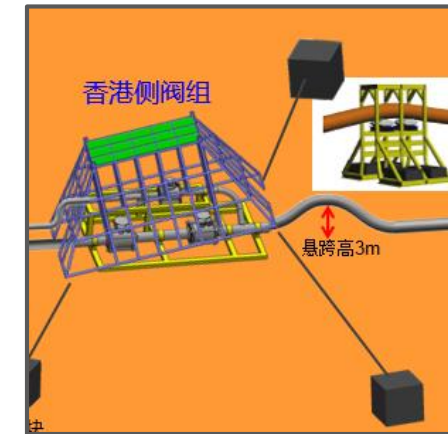
In October 2013 an anchor strike damaged a 780km 28" gas pipeline from Yacheng Platform to Hong Kong.

Damage occurred in a water depth of 90m at the future midline gas compression PLEMS.

- North PLEM overturned and offset by 3m.
- 28" Pipeline tie-in section at North PLEM severely buckled ~ secured and supported the damaged pipe section.
- 14" bypass (400m) installed between South PLEM and North PLEM ~ 28" valves closed.
- Two leaks from valves in the North PLEM sealed.

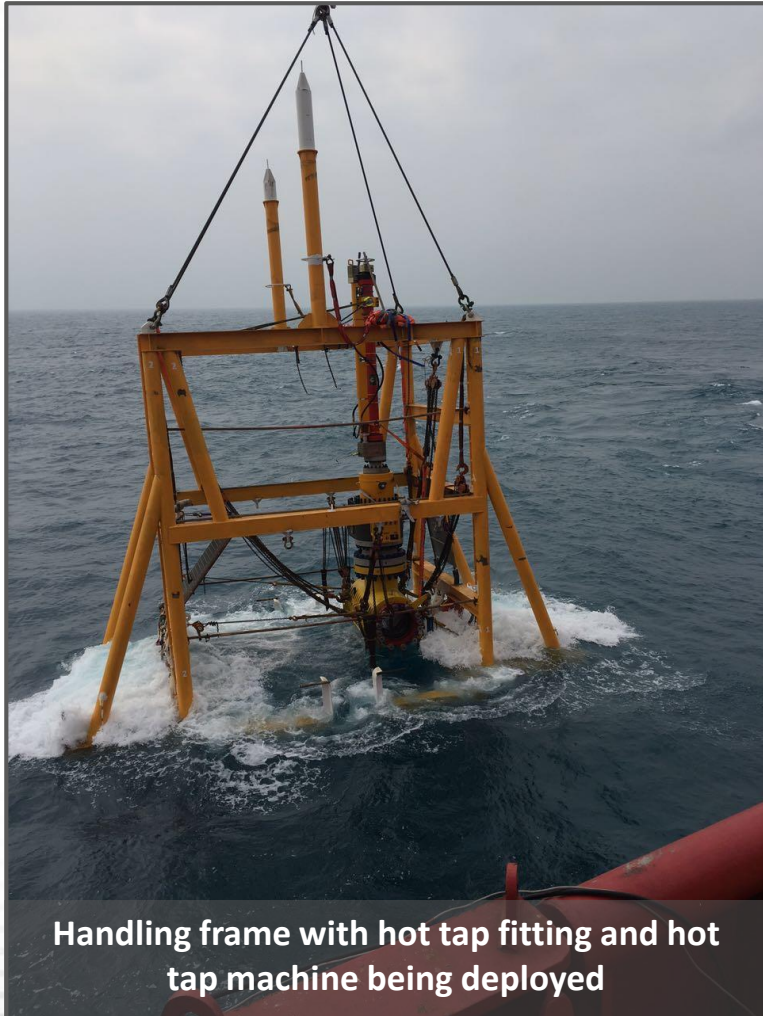
Handling frame with hot tap fitting and hot tap machine being deployed

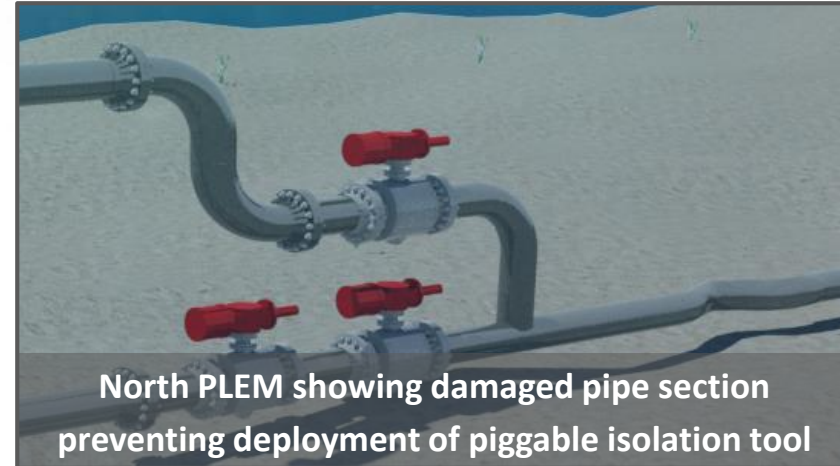
North PLEM showing damaged pipe section preventing deployment of piggable isolation tool

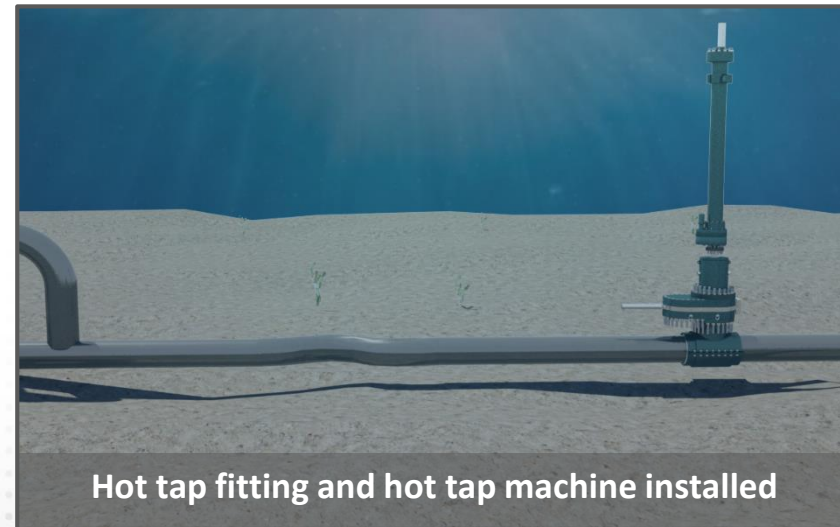
Hot tap fitting and hot tap machine installed

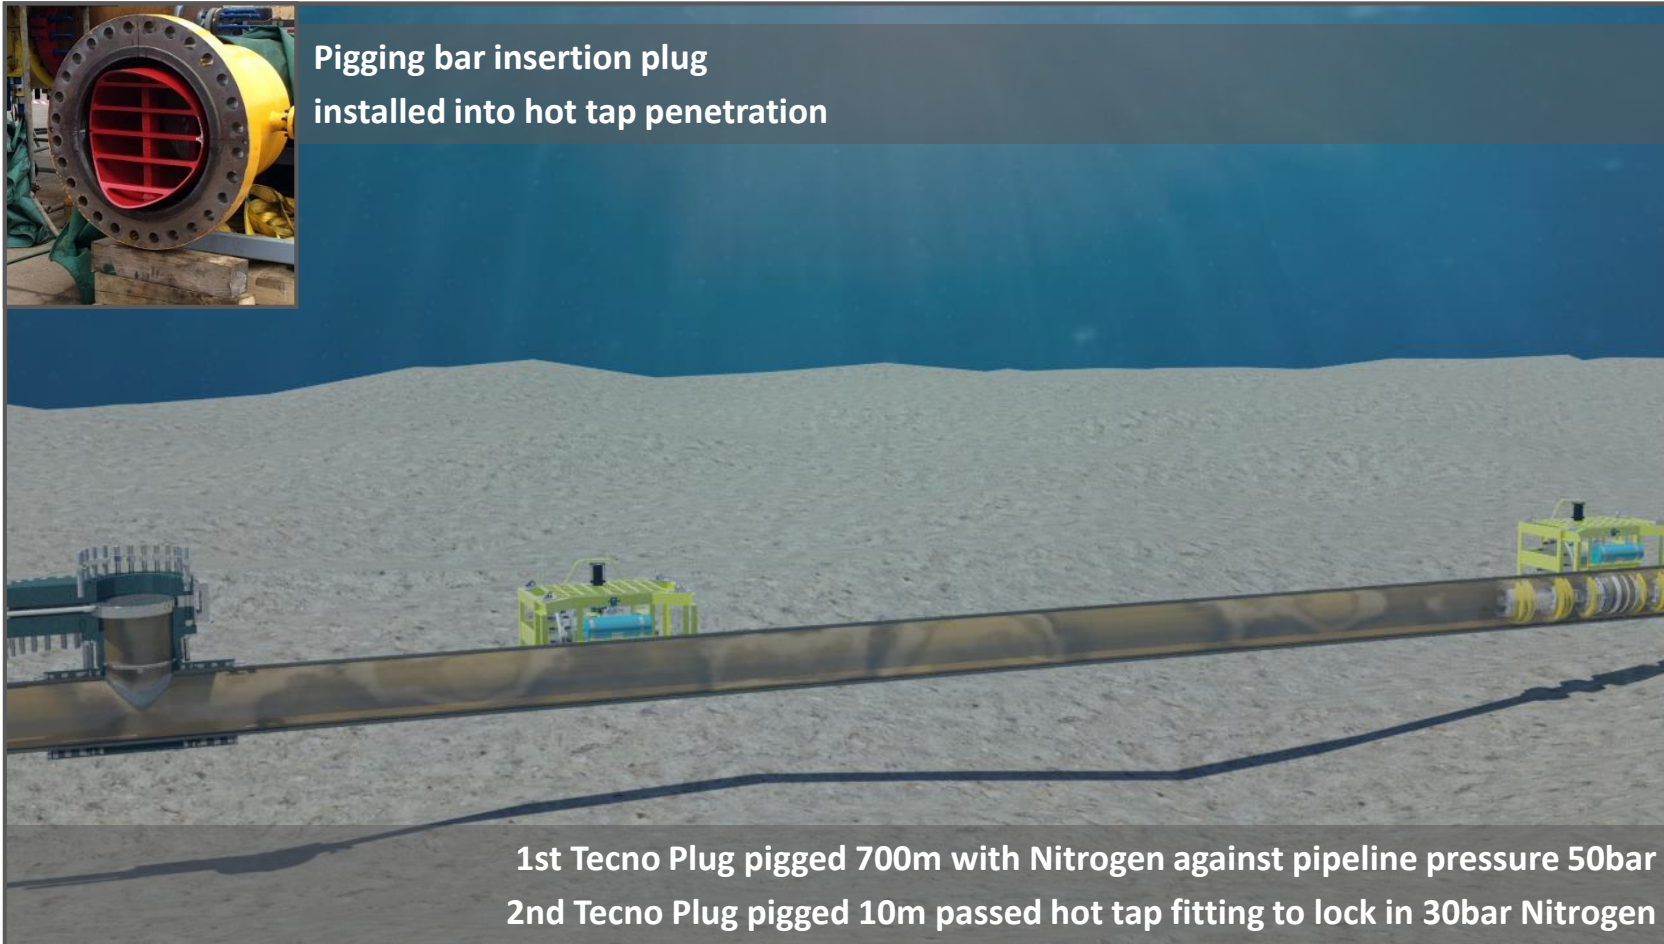
Pigging bar insertion plug installed into hot tap penetration

1st Tecno Plug pigged 700m with Nitrogen against pipeline pressure 50bar
2nd Tecno Plug pigged 10m passed hot tap fitting to lock in 30bar Nitrogen

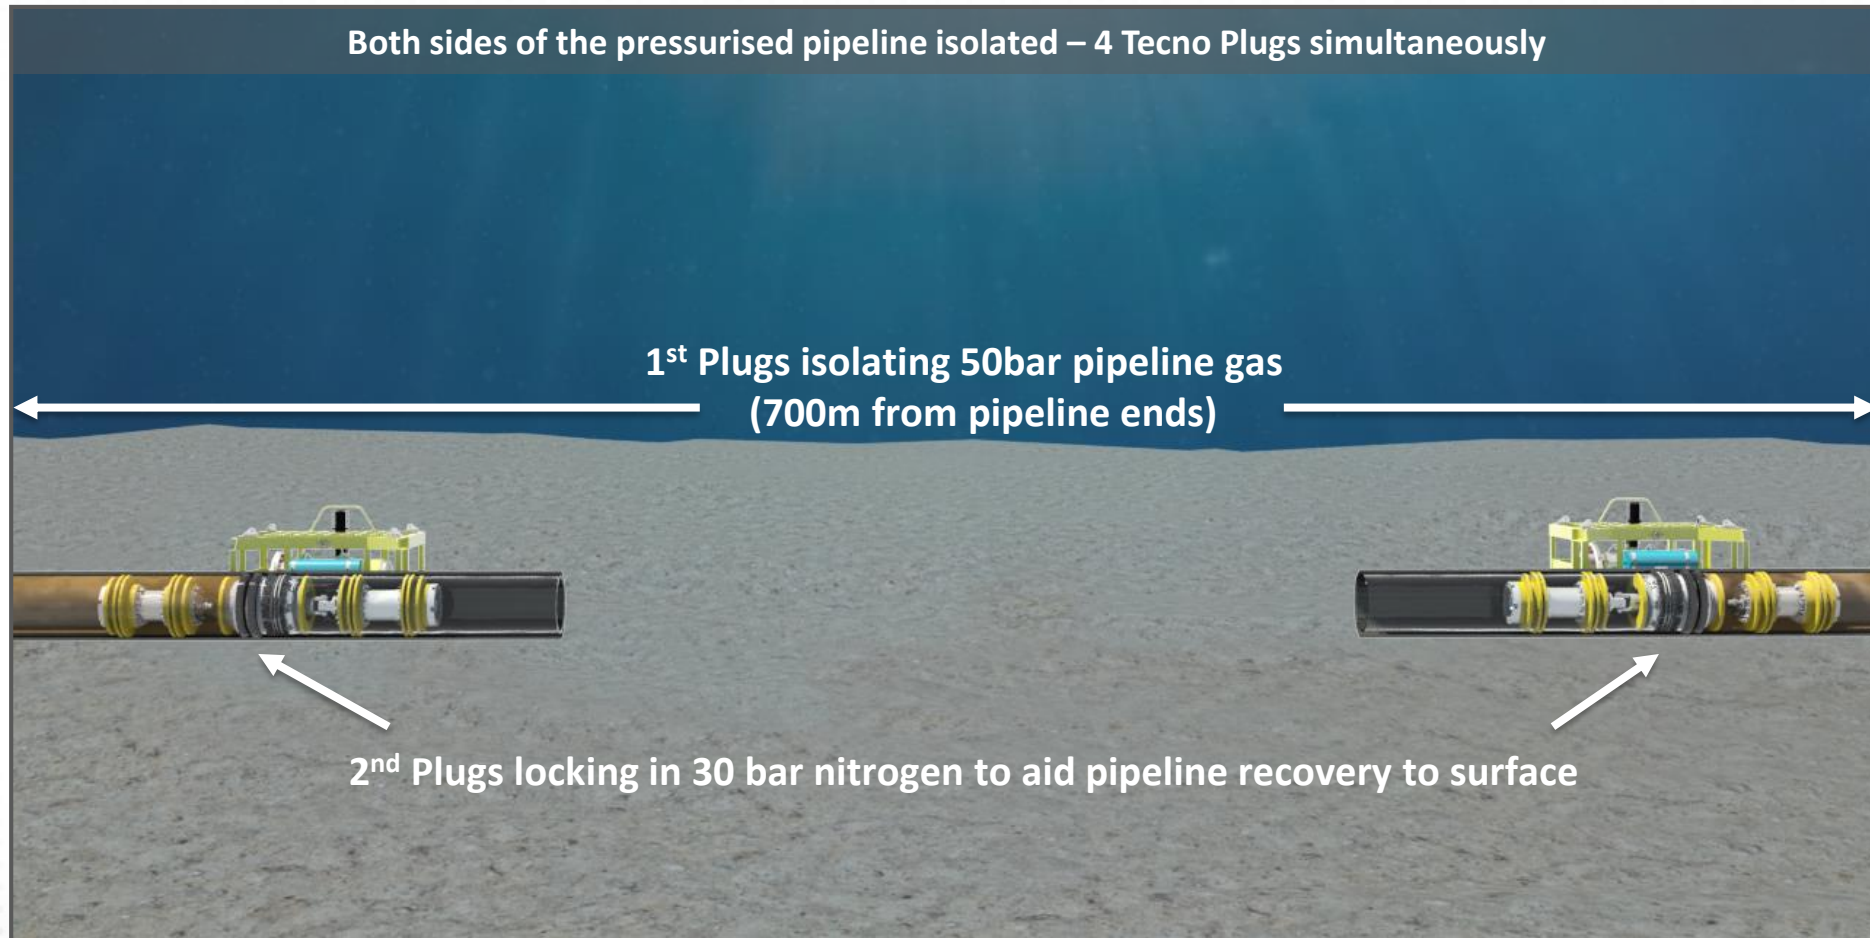
Pipeline Isolated with Tecno Plugs – 4 Plugs Simultaneously

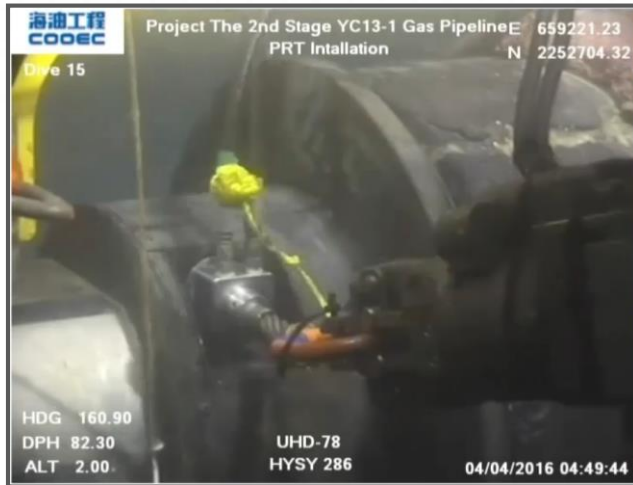
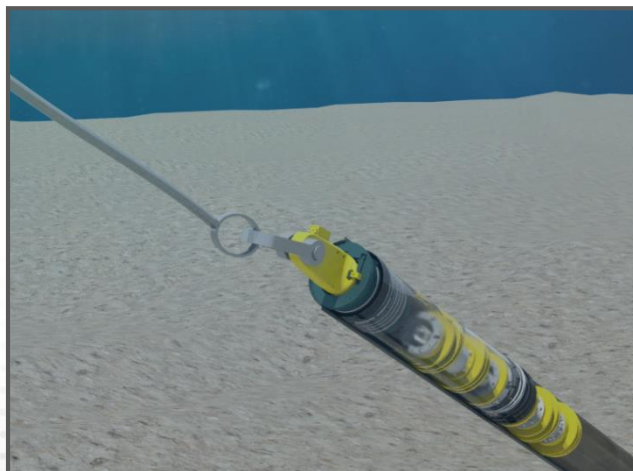
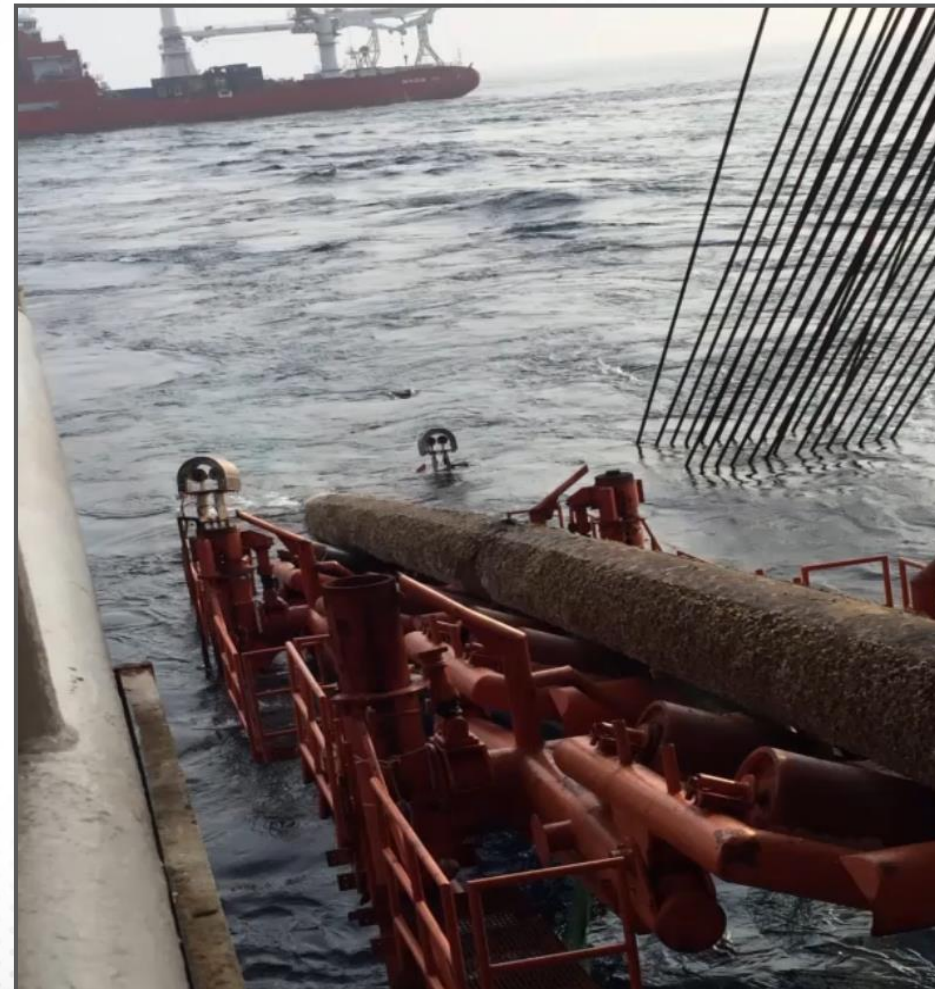
Pressurised Pipeline Recovery: PRT Recovering Pipeline Ends onto Pipelay Vessel

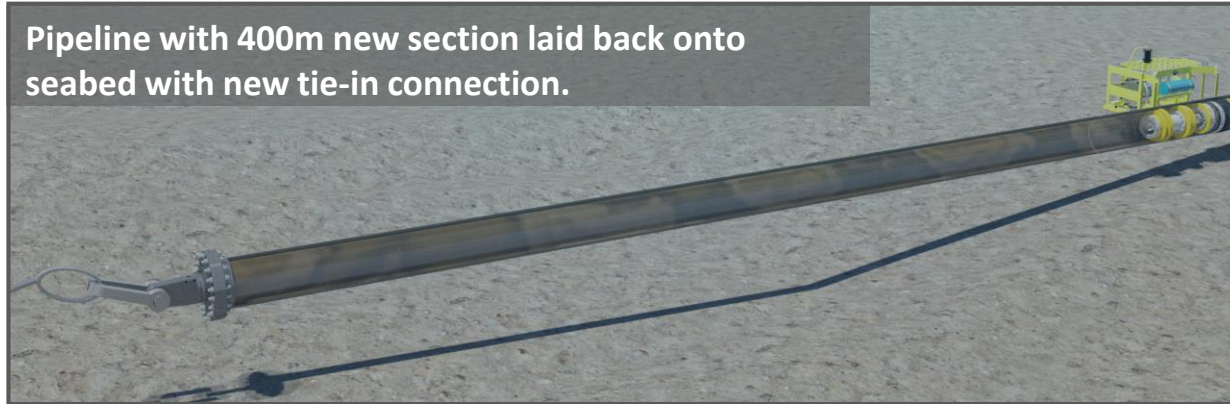
Pipeline with 400m new section laid back onto seabed with new tie-in connection.

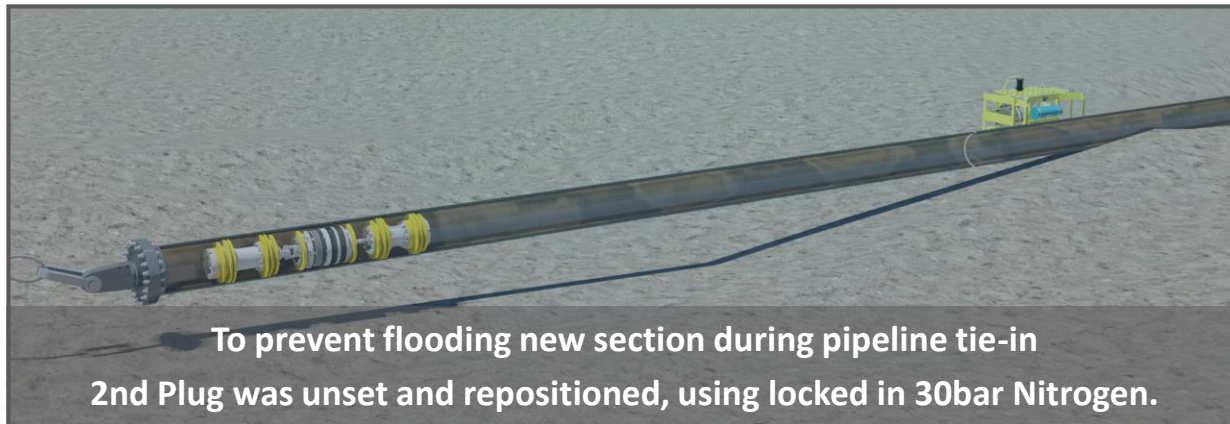
To prevent flooding new section during pipeline tie-in
2nd Plug was unset and repositioned, using locked in 30bar Nitrogen.

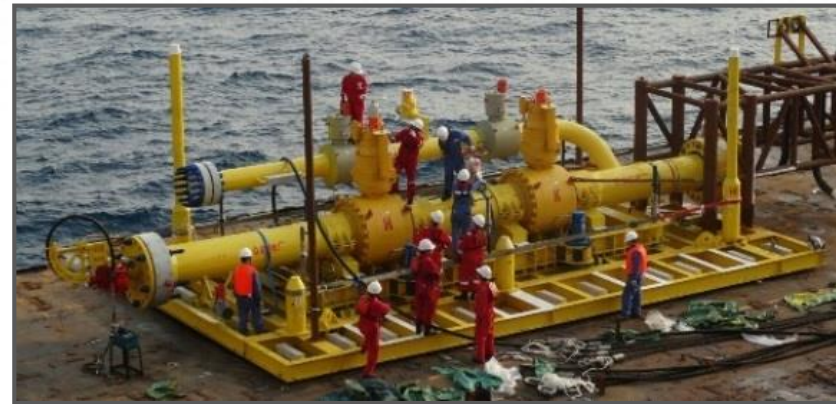
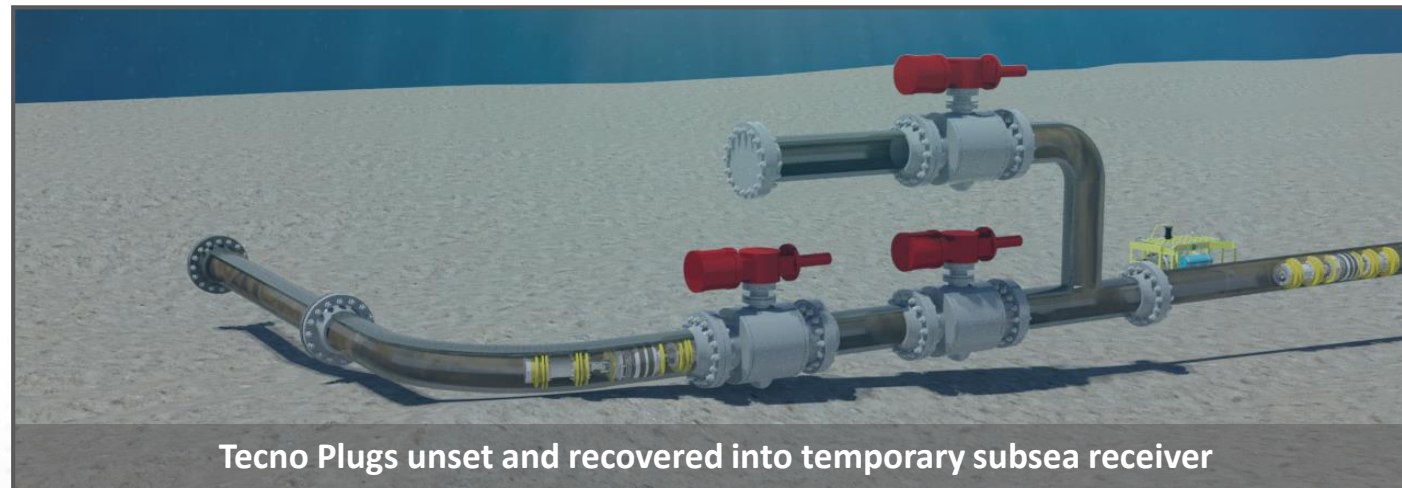
Tecno Plugs unset and recovered into temporary subsea receiver

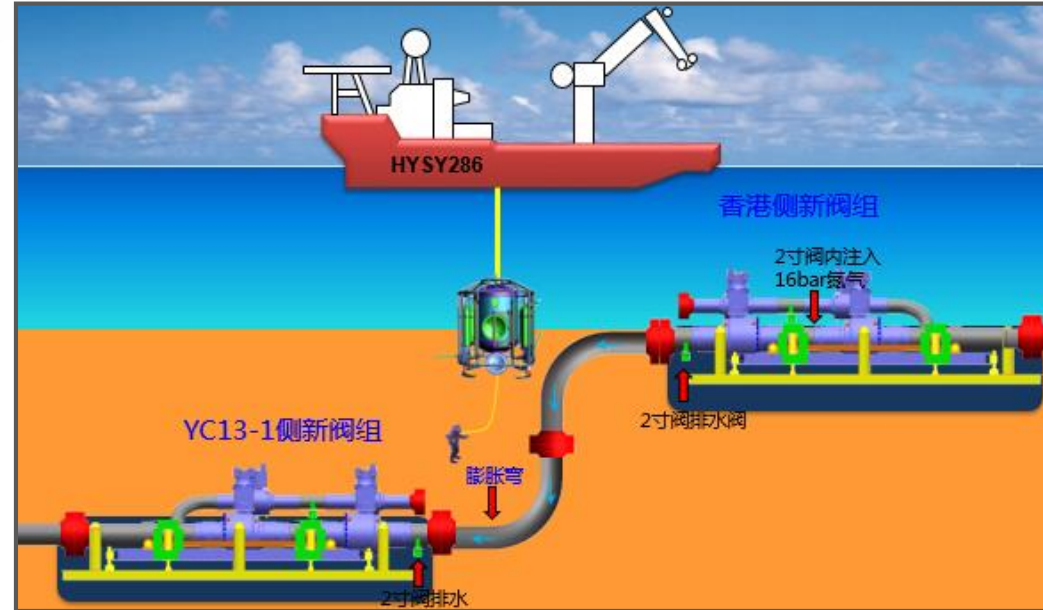
New PLEM's (25m apart) Connected Together with Closure Spool
