DEVELOPMENT OF THE PATHFINDER FOAM CALIPER PIG

By: Peter Ward & Dave Cockfield
Pipeline Innovations Ltd, UK

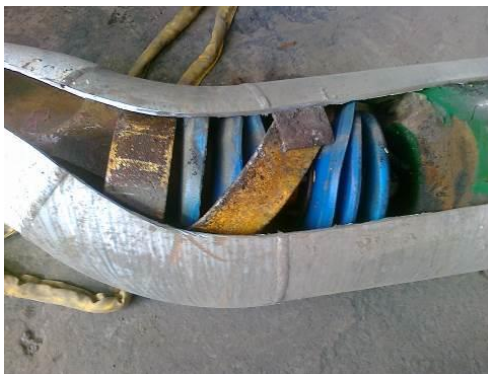
Cleaning Pig Stuck In Bend

Development of the Pathfinder started in 2009 and in 2013 PIL presented a paper to the PPSA on the development process, from the initial concept through to the production of operational tools. At that time, PIL had a limited range of tools for pipe sizes from 6" to 12" with a maximum operating pressure of 20bar. We had carried out only six operational projects but already the tool was showing great promise. The very first line that we were asked to run (a 12" refined product terminal to tank farm line) had proven to be impossible to pig using hard bodied pigs due to the presence of deteriorating internal anodes that were detaching from the pipe wall causing the pigs to stick in the line.

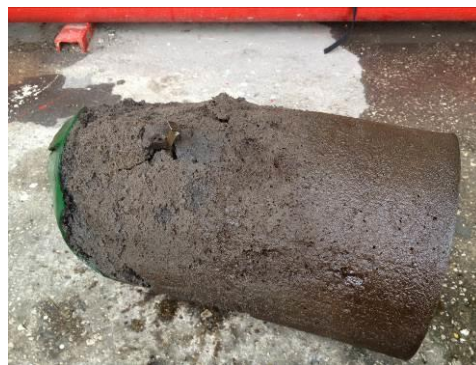
Pathfinder After Run

On the first attempt, a Pathfinder was successfully run through the line and despite significant damage to the front of the pig, the rear end containing the measurement system remained intact and good quality caliper data was obtained over the full length of the line. Using the bend detection system on the pig and correlating with strip maps provided by the client a total of 144 internal anode features were positively identified and locations pinpointed.

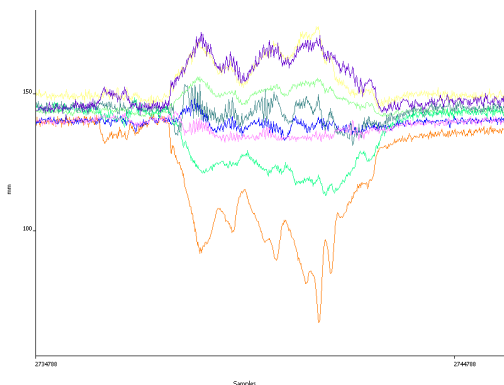
Run 1 Data

A bore proving run by the Pathfinder on a Subsea pipeline offshore Sicily, prior to running an MFL tool identified an unexpected and severe restriction in the line. This occurred on a 12" crude oil pipeline offshore Sicily. The pipeline was a relatively short run of 3km from an offshore platform to an onshore terminal. The Pathfinder run was completed uneventfully and the Pathfinder was received in good condition and undamaged. However, when the data was downloaded, a large anomaly was identified in the data about 12 minutes into the run.

In order to confirm the findings two more Pathfinder runs were carried out with similar results obtained. The caliper data indicated that the anomaly extended over a pipe length of 13m to 15m with a maximum bore reduction of 86mm to 100mm. The pipe section containing the anomaly was excavated and it was confirmed that the damage matched the Pathfinder findings. The damaged section of pipe was cut out and replaced with new pipe spools allowing the cleaning and inspection of the line to be completed.

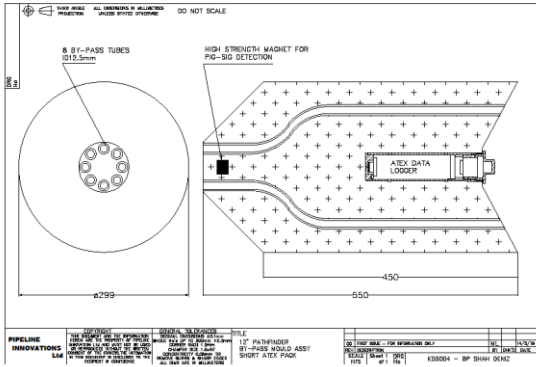
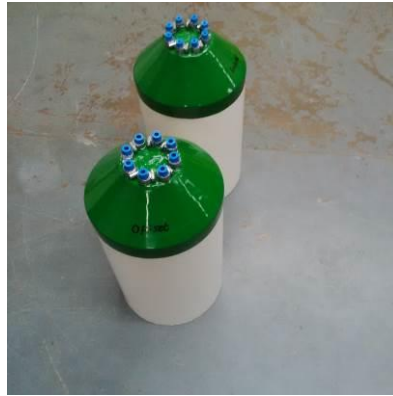
Jetting Pathfinder

A growing application area for Pathfinder is to assist with pipeline cleaning programs by providing information on the thickness and distribution of deposits along the pipeline at an early stage in the cleaning process before hard bodied cleaning pigs are introduced. If it is suspected that significant quantities of wax or sand may be present then the rate of removal of the deposits could be significant, even with foam pigs, leading to the risk of blockage of the line due to buildup of debris in front of the pig. This has led to the development of the Pathfinder high bypass Jetting pig which has an array of bypass tubes passing through the pig body to produce high velocity jets issuing from the nose of the pig creating turbulence and flushing debris away from the pig.

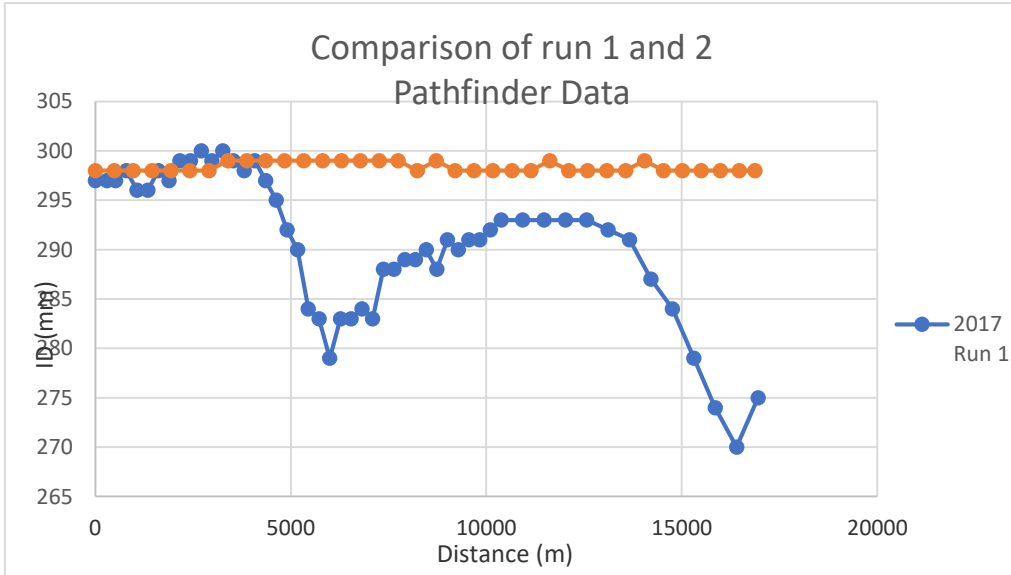
A mean bore plot of the pipe bore showed that the wax thickness peaked at a distance of about 15km from the launch creating a bore restriction of about 30mm. Using this information, RHC were able to optimise their tool configurations and cleaning program for this operation to maximise cleaning performance over a reduced number of runs.

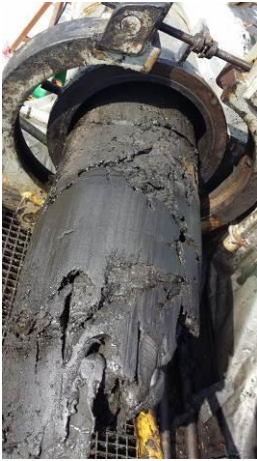
Wax During Cleaning

Significant quantities of wax were removed and the Pathfinder was re-run at the end of the programme confirming that the line was clean.

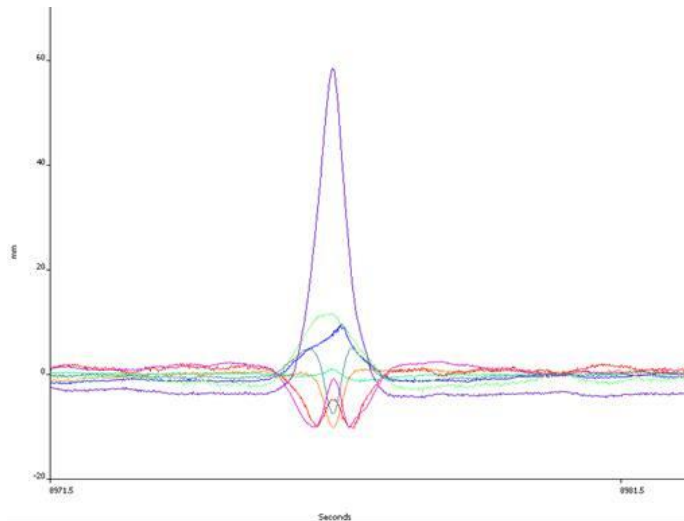
Pathfinder Caliper Response

The response of the caliper sensors in the anomaly suggested an outward bulge in the pipe at the 1 o'clock position with a maximum outward displacement from the normal pipe profile of 60 mm. The anomaly also appears to have ovality components in the 3 to 9 o'clock position with a maximum bore reduction of 20mm. At the 3 o'clock and 9 o'clock positions, smaller responses were observed either side of the central bulge response. The axial length of the anomaly was approximately 0.8m. In addition, the gyro sensors, which measure changes in the heading angle of the pig, show a change in angle across the anomaly of approximately 6 degrees for run 1 and 8 degrees for run 2.

An outward bulge of this magnitude is something that had not either been tested for or previously experienced by the Pathfinder in operational pipelines but our interpretation was that it was a complex type of buckle with an outward bulge on the top of the pipe and indentations on both sides of the pipe. After receiving our report the constructor carried out a more detailed ROV video survey at the location indicated by the Pathfinder.

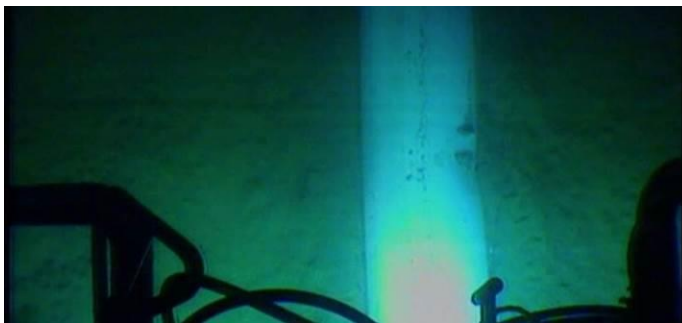
Location Of Buckle

The video survey located the anomaly at the positions predicted by the Pathfinder. The outward bulge on the top of the pipe was not easily visible due to the viewing angle but the indentations at the 3 o'clock position were clearly visible.

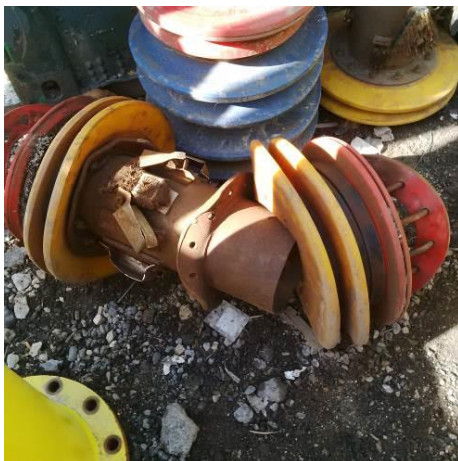
Damaged Cleaning Pigs

A Pathfinder run was successfully carried out without damage to the pig. Analysis of the data revealed a number of thick wall bends in the line which were causing pigs to stall and then overspeed on exit of the bend. The damage to the Bi-Di pigs was being caused by the pigs crashing at high speed into the next downstream bend. Whilst the Pathfinder data showed that the pig was suffering the same high speed excursions, the foam pig body was acting as a shock absorber, protecting the pig and the datapack from damage.

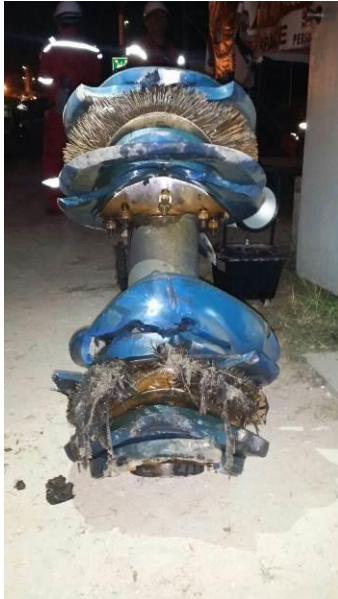
Cleaning Pig Damage

Cleaning and gauging pigs running as part of the pre-commissioning operations were being received in a badly damaged condition. A Pathfinder run was carried out to locate and identify the cause of the blockage.

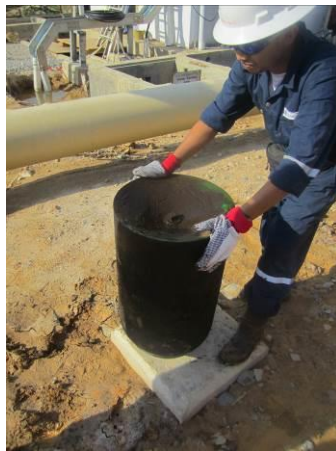
Pathfinder After Run

The run was completed with no damage to the pig. Data analysis showed a significant dent approximately 33km from launch. By matching the girth weld count from the caliper data with the pipe tally in the as-laid pipe book, it was possible to identify the exact GPS coordinate location of the dent. Using this information the pipe was excavated and the damage pipe spool located.

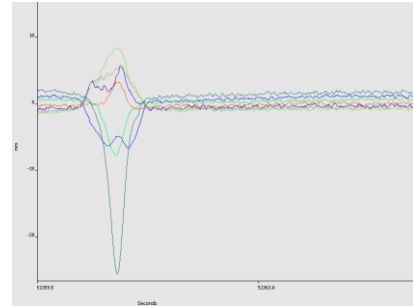
Pathfinder Dent Response

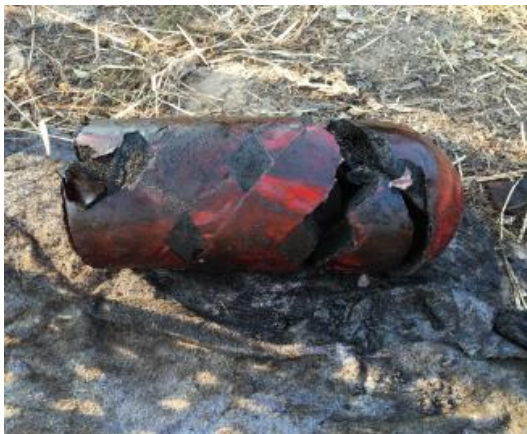
Foam Cleaning Pigs

The pipeline operator had been carrying out a pigging campaign to clean the line using a variety of foam pig configurations. A total of 17 foam pigs had been run through the line and all had emerged badly damaged. As a result the operator had been unable to progress to the next stage of the cleaning program, using hard bodied pigs, for fear of the pigs getting stuck in the line.

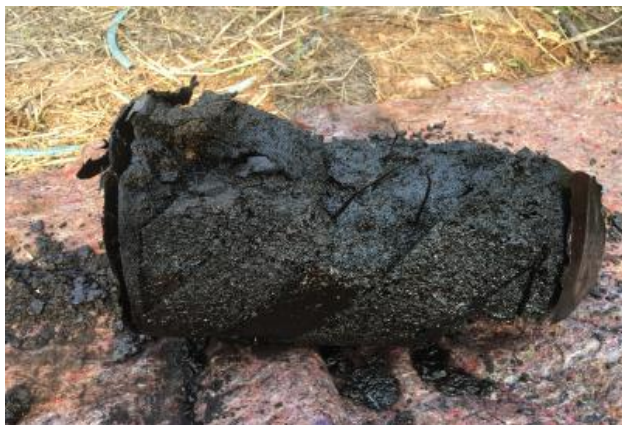
Because of the high risks of running an intelligent pig in the line , PIL requested that a run be carried out using a dummy Pathfinder to determine whether it was feasible to run the full Pathfinder tool. The dummy Pathfinder is a pig made from the same material and to the same dimensions as the Pathfinder but without the datapack or measurement system. The dummy came out badly damaged but the rear of the pig was intact indicating that there was a good chance that the datapack and measurement system would survive. A decision was taken therefore to run the Pathfinder.

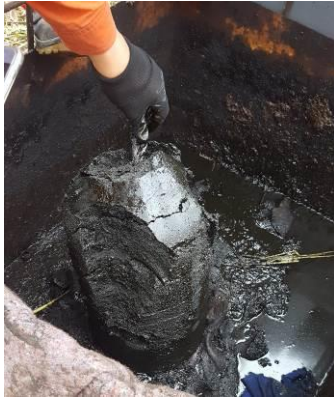
Dummy Pathfinder

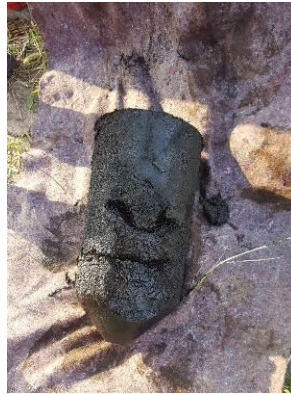
The Pathfinder completed the run in the expected time but when the pig emerged it was also badly damaged, with large pieces of the foam body missing, even towards the rear of the pig. However, the datapack and measurement system had survived the run and a full set of data covering the full run length was downloaded.

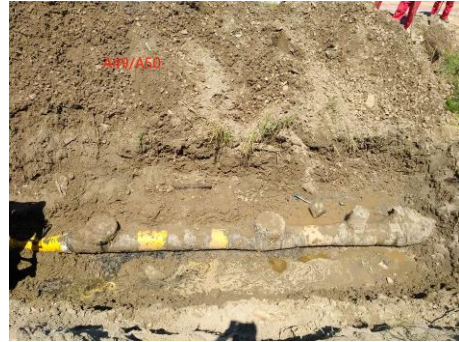
Hot Taps

A total of fifty anomalies greater than the reporting criteria were identified, 15 of these showing bore reductions greater than 20% of nominal bore. Follow up excavations have been carried out at three locations to date, two of these revealing hot taps.

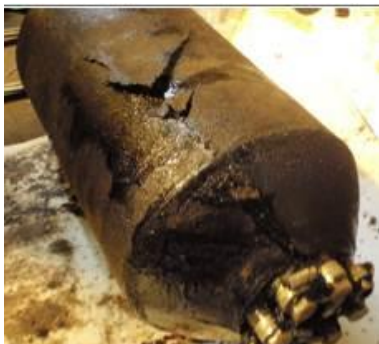
Pathfinder After Run

In order to minimise the risk of the pig sticking, the Pathfinder was designed to-replicate the existing operational foam cleaning pigs with same OD, same bypass and same foam density. When the Pathfinder run was carried out the pig passed through the line OK but the nose of the tool was damaged and there were tear marks down the length of the body.

The Pathfinder data shows that the pig performed normally until entering the topside pipework on the receive platform when a very large anomaly occurred in the caliper data. The anomaly occurred on the caliper sensor running in the 10 o'clock position. The nature of the damage to the pig suggested that it was caused by a tube or probe protruding about 100mm into the bore of the pipe

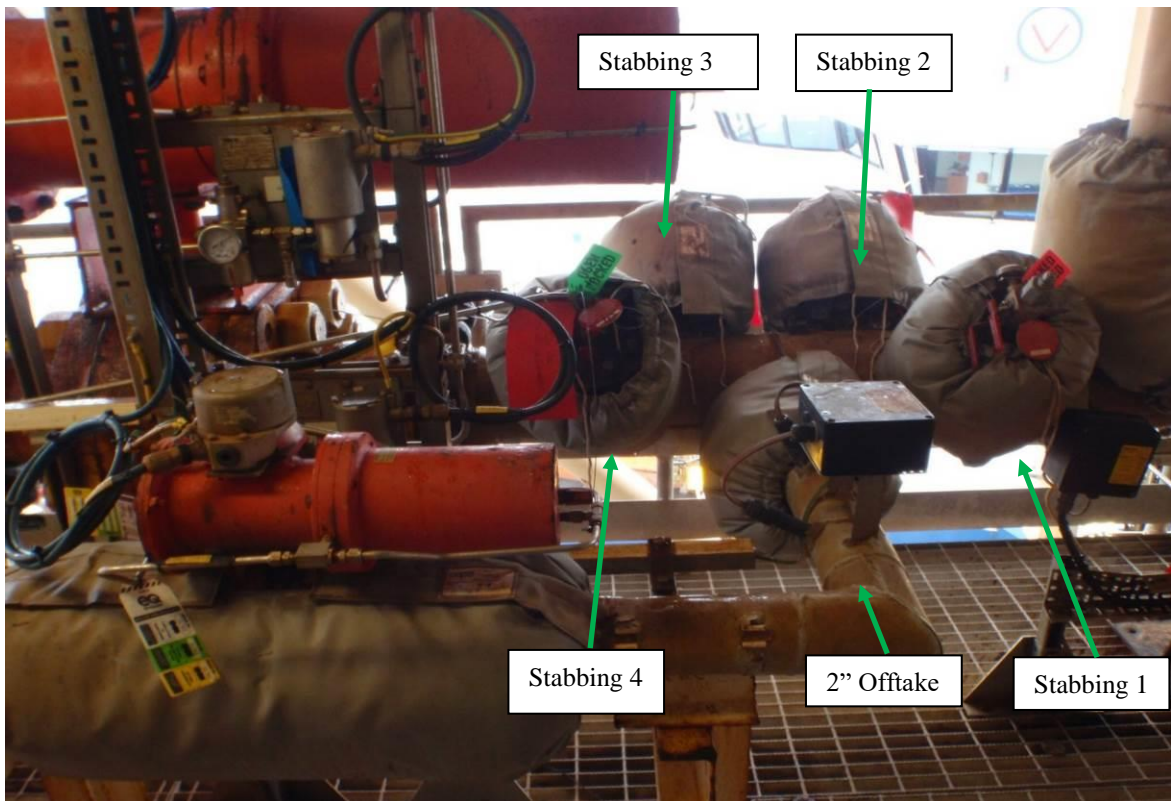
By matching the Pathfinder data to known features in the line, it was possible to narrow down the location of the object protruding into the pipe to an area containing four 2" stabbings and a 2" offtake. This would indicate that the most likely candidates would be the fittings in stabbing 1 or stabbing 4 on the photo
