ASSESSING THE ACCURATE TOPOGRAPHY OF COMPLEX CHANNELING CORROSION BY MEANS OF ULTRASONIC WALL MEASUREMENT TOOLS: A CASE STUDY AND EXPERIENCES

Kerstin Munsel[1], Dr. Katherine A. Hartl[2],
Dr. Christoph Jäger, M. Santiago Urrea[2]
[1] NDT Global LLC, Houston, Texas
[2] NDT Global GmbH & Co. KG, Stutensee, Germany

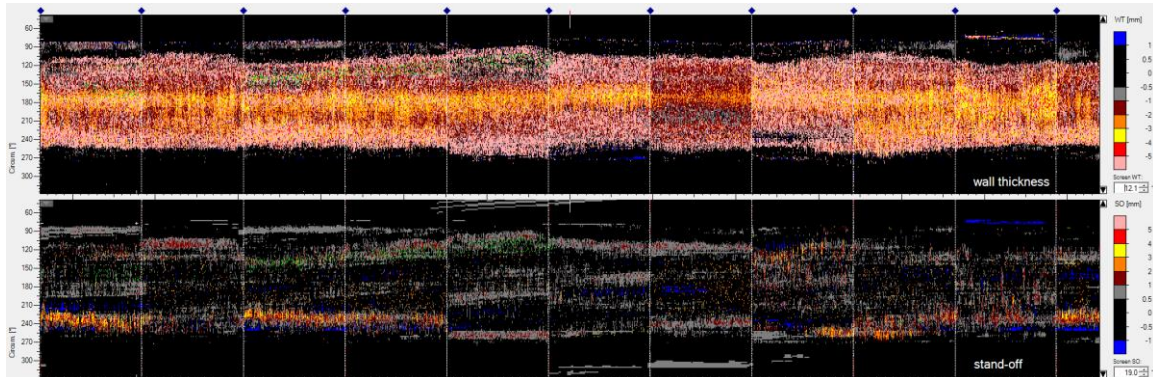
Figure 1: Top: Wall thickness C-Scan showing a section of coherent channeling corrosion across 10 pipe joints (~410ft. / 125m). Bottom: Stand-off C-Scan showing deeper areas of metal loss within the wall affected by the broad channeling corrosion. The color-scale indicates deviation from nominal wall thickness, and nominal stand-off respectively.

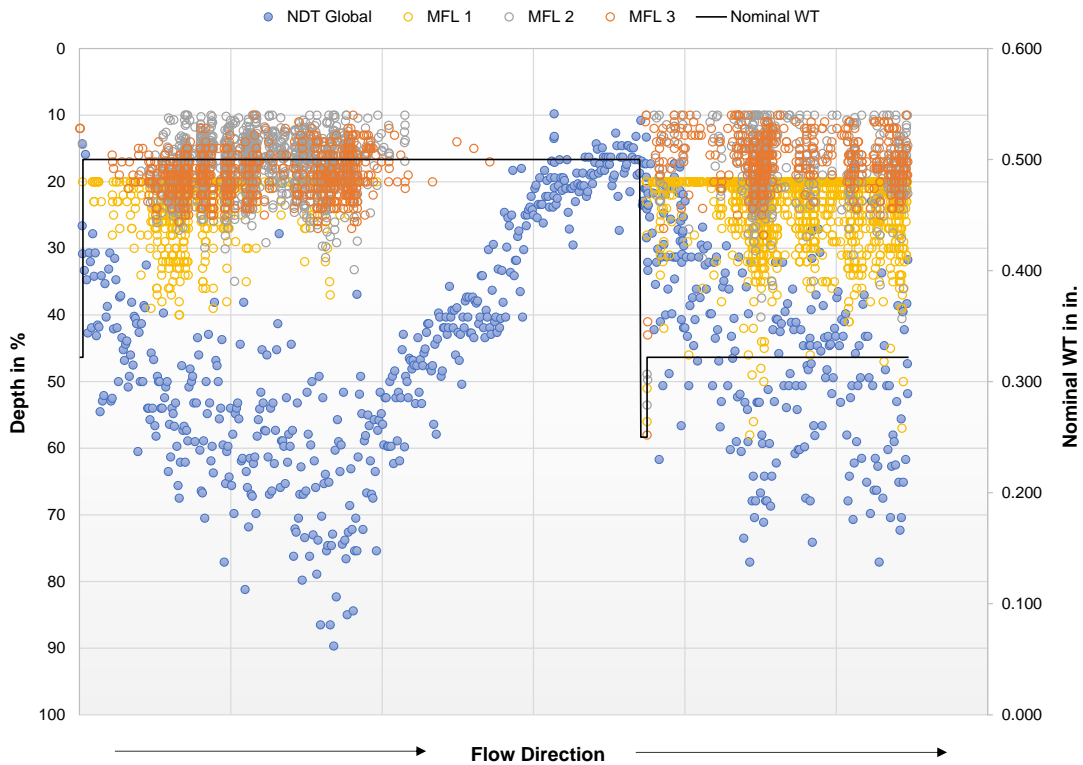
Figure 3: Depth distribution of features according to the different vendors

Both Table 1 as well Figure 3 reveal significant differences in the results between the UTWM and MFL measurements, but also significant differences among the MFL vendors.

All ILI vendors were able to cover the dominant areas of channeling corrosion, but in varying degrees of quantity and quality. MFL 2 and MFL 3 provide almost the same results with depths that are much shallower than the UTWM measurement, whereas MFL 1 takes a middle position between all results. The most obvious fact is, that none of the MFL results matches the deepest UTWM results, confirmed by the pipeline operator and its own investigations with Non-Destructive Examination (NDE).

All MFL results show that the different wall thicknesses and the magnetization of the tool have a clear impact on the data recording. This is clear when considering the nominal wall thickness in Figure 3. For the section of the pipeline with a nominal wall thickness of 0.500 in/12.7mm, the MFL vendors significantly undercall the feature depths. In the section of the pipeline with a nominal wall thickness of 0.325 in, the discrepancy is less significant. This difference could be due to the effects of different magnetization levels within the different wall thicknesses. Further, within the 0.500 in/12.7mm section, the UTWM data shows a steady increase in feature depth with distance. None of the MFL data captures this gradient, possibly due to the circumferential extent of the channeling corrosion reducing the wall thickness and obscuring the MFL measurement.

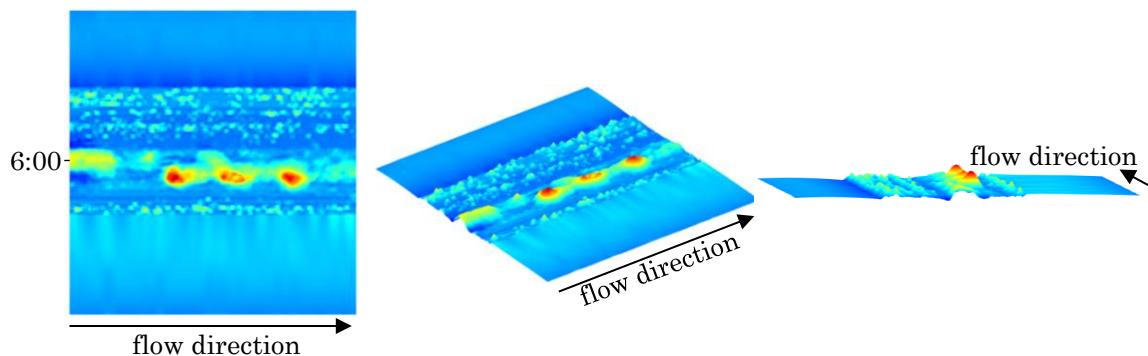
Besides the reporting of the correct depths and reliable information about the remaining wall thickness, the direct and precise measurement with UTWM means it is also possible to create an exact topography of the bottom-line corrosion and to recognize differences within certain areas. For example, in Figure 4 the shape of the internal corrosion is clearly visible. There are 3 distinct bands of channeling across the circumferential direction. There is a band along the 6 o'clock position that has large, deep pits visible. The bands on either side of this central band have many smaller, shallower pits. This is consistent with concept of pitting chains that form together to generate the channeling. In this case, the channeling bands take up about 50 % of the inner circumference of the pipe. Additionally, this topography is useful for advanced integrity investigations.

Figure 4: Three views of the measured stand-off of a section of the offshore pipeline to demonstrate the internal channeling corrosion topography collected with UTWM technology. The colors are proportional to the value of the stand-off.

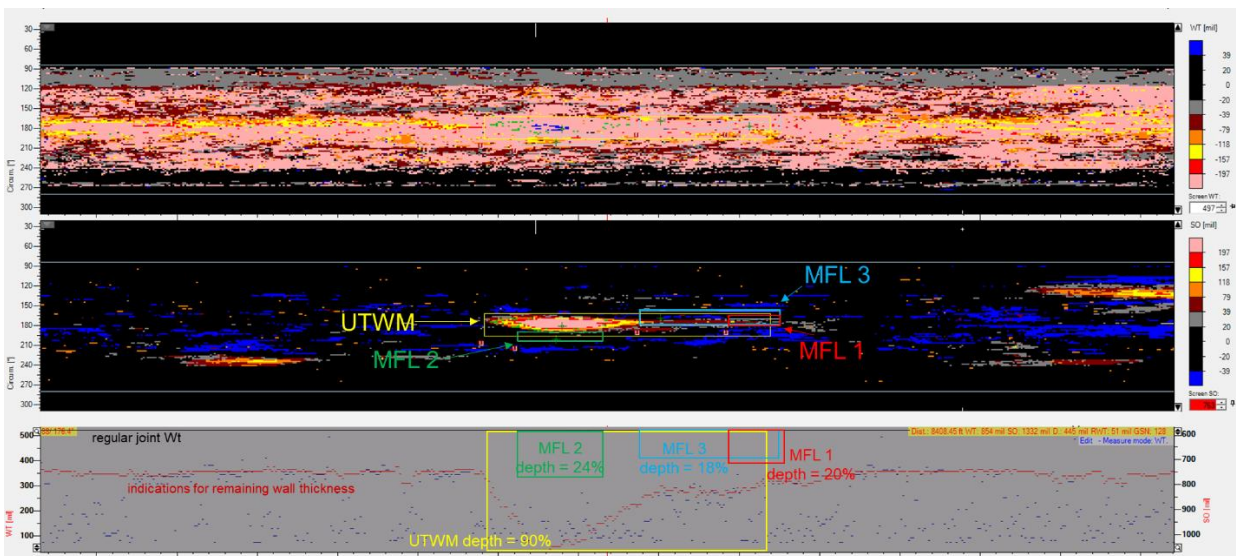
While not all corrosion spots were consistently identified by vendors along the length of the pipeline, the deepest point was detected by all vendors. But while the UTWM measurement delivered a depth of 90 % with indications of a possible leakage for that point, the MFL results delivered significantly lower depths, around 20 %, as the projections in Figures 5 and 6 show. The blue, red and green boxes in the bottom third of Figure 5 shows that the MFL detection is only focused on the metal loss due to the channeling corrosion. Examining the figure, the depth of the boxes is close to the local wall thickness, marked in red. The total height of the area represents the nominal wall thickness. The real gap between reference wall thickness and remaining wall thickness caused by the local metal loss within the channeling is not considered. The axial cross section of the pipe in Figure 6 illustrates the circumferential extent of the channeling corrosion and gives a reference for the size of the deeper metal loss within the channeling. It appears the channeling obscured the axial MFL measurement.

Figure 5: Top: Wall thickness C-Scan for a section of the joint (~1.5ft. / 0.5m) containing the deepest point. Middle: Corresponding stand-off C-Scan. Bottom: Corresponding B-Scan showing the wall thickness through the deepest point. The colored boxes indicate the approximate axial location and depth of the MFL and UTWM boxes. Depth differences for the deepest point in axial direction. Due to slight differences in the odometers for each run, the exact axial position can be neglected.

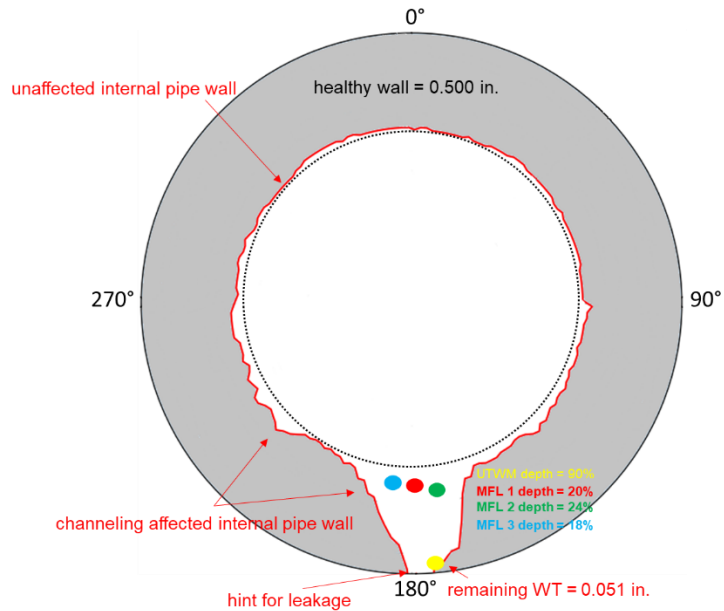
Figure 6: Depth differences for the deepest point in a cross section, constructed from UTWM data.

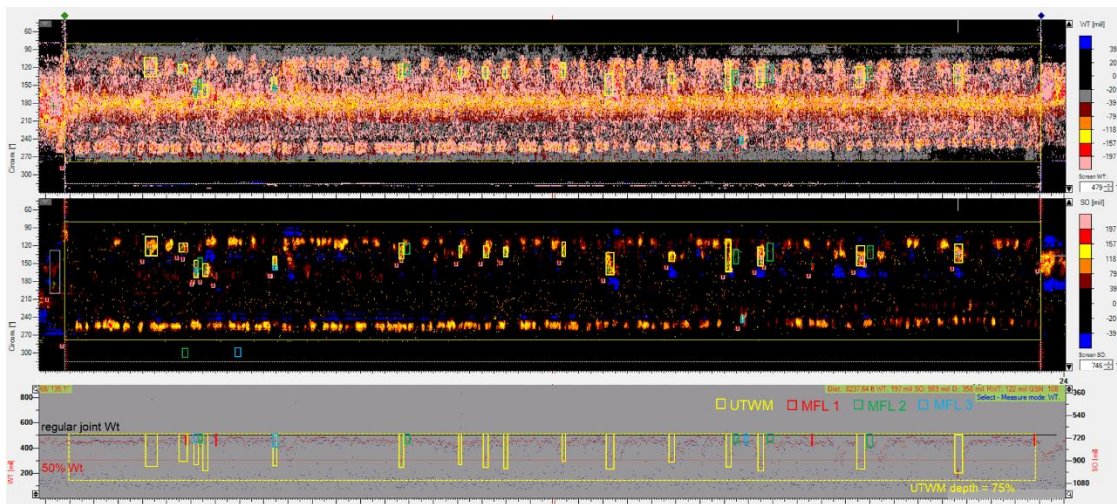
Figure 7: Top: Wall thickness C-Scan for an entire joint (~40ft. / 12m). Middle: Corresponding stand-off C-Scan. Bottom: Corresponding B-Scan showing the wall thickness through the deepest point. The colored boxes indicate the approximate axial location and depth of the MFL and UTWM boxes. Due to slight differences in the odometers for each run, the exact axial position can be neglected.

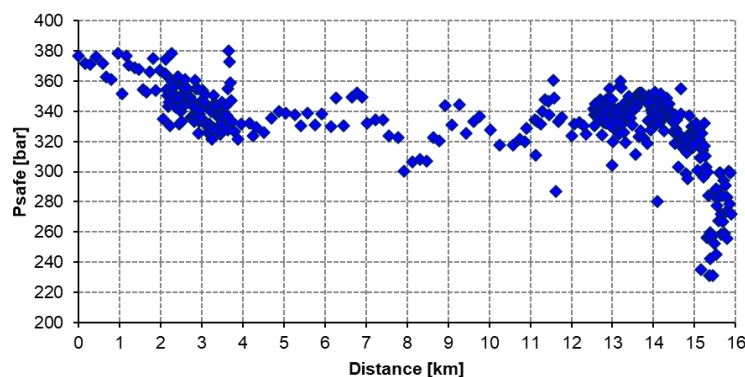
For the demonstration pipeline here, 370 pipe joints showing significant channeling corrosion were selected for the assessment. For the worst pipe joint, a safe operating pressure of 231 bar was calculated according to the Complex Shaped Defect method of DNV-RP-F101 Part A. This is below the original pipeline design pressure of 245 bar, but significantly higher than the relevant MAOP of 150 bar. Figure 8 shows a significant variation of the P_{safe} values with distance. The lowest pressure values are concentrated in a short section between km 15 and km 16.

Figure 8 – Safe operating pressure of assessed pipe joints according to DNV-RP-F101 Complex Shape Part A

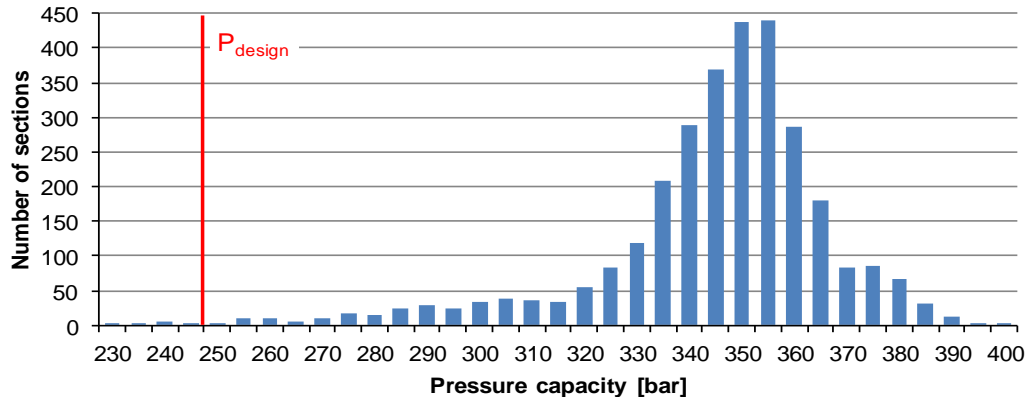
Figure 9 – Histogram of pressure capacity for 1.5 m (4.92 ft) long pipe sections

Following the Appendix D procedure and accounting for the system effect, a safe working pressure of the pipeline system of 223 bar was calculated. The pressure capacity of the pipeline system is 8 bar (4 %) below the pressure value of the worst pipe joint. In cases where more pipe joints have low P_{safe} values, a higher system effect, i.e. a higher reduction of the pipeline system pressure capacity compared to the worst feature, is expected.

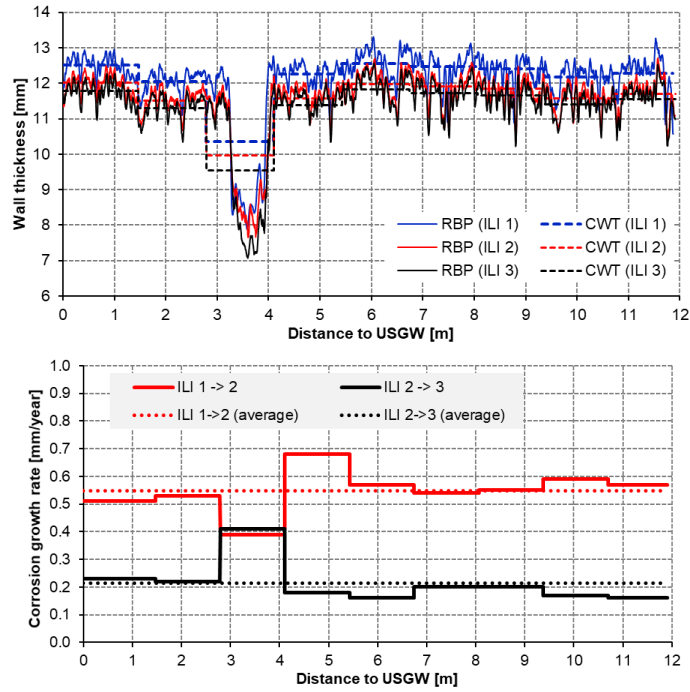
The procedure is shown in Figure 10. The top figure shows RBPs of 3 ILIs for one pipe joint. The resulting corrosion growth rates are shown in the bottom part of this figure. In this example, the overall growth rate was reduced from approx. 0.55 mm/year (between ILI 1 and ILI 2) to 0.20 mm/year (between ILI 2 and ILI 3). However, corrosion growth at the deepest spot of this anomaly remained constant between ILI 1, ILI 2, and ILI 3.

Figure 10 – Example of corrosion growth assessment by comparison of river-bottom profiles (one pipe joint). Top: river-bottom profiles and characteristic wall thickness, bottom: growth rates

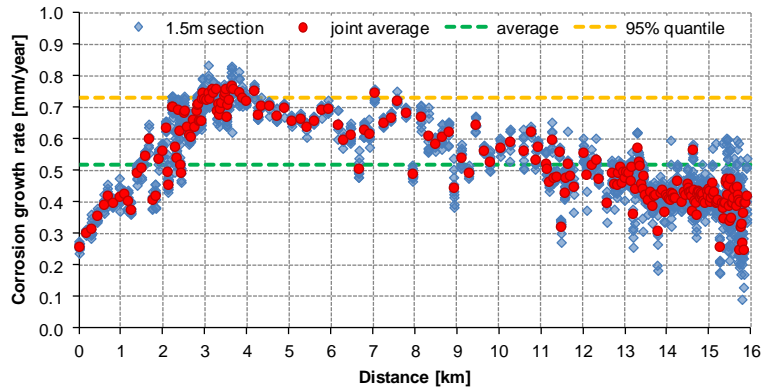
The corrosion growth rates for all assessed pipe joints are plotted in Figure 11. The corrosion growth behaviour varies along the distance, with maximum growth rates observed between km 3 and km 4.

Figure 11 – Corrosion growth rates vs. pipeline distance (red dots: pipe joint average growth rates, blue dots: growth rates for 1.5 m sections)

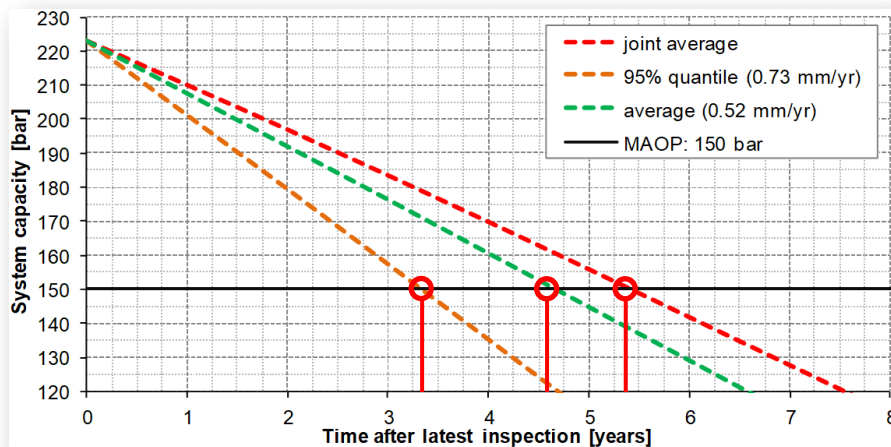
After determination of the pipeline pressure capacity at the date of the latest ILI, and after the corrosion growth assessment is performed, the future development of the pipeline safe operating pressure can be extrapolated. This is achieved by reducing the remaining wall thickness of the RBPs according to the considered corrosion growth rates and by repeating the capacity assessment as described above. Depending on the considered corrosion growth rate, the extrapolated pipeline pressure capacity will reach the MAOP of 150 bar 3.5 to 5.5 years after the latest inspection (see Figure 12).

Figure 12 – Extrapolation of pipeline pressure capacity
