FLAGS PIPELINE IN-LINE INSPECTION

PPSA 08/11/17

FLAGS (Far North Liquids and Associated Gas) pipeline system

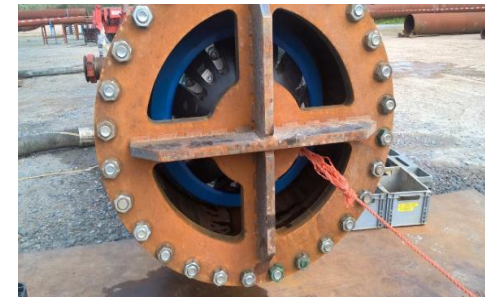
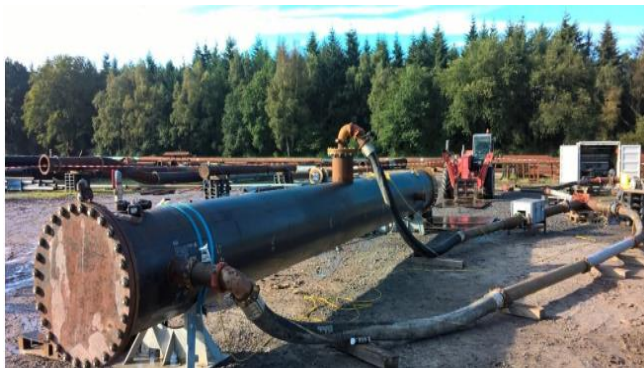
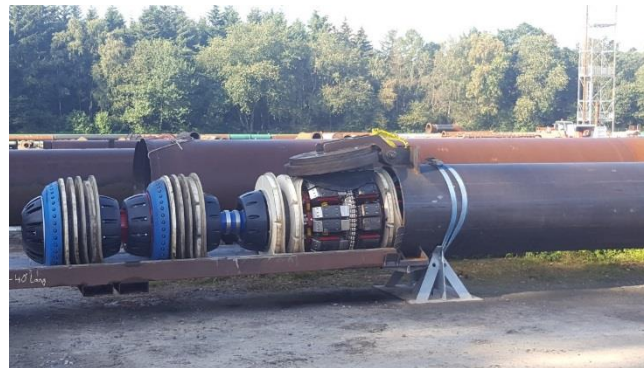
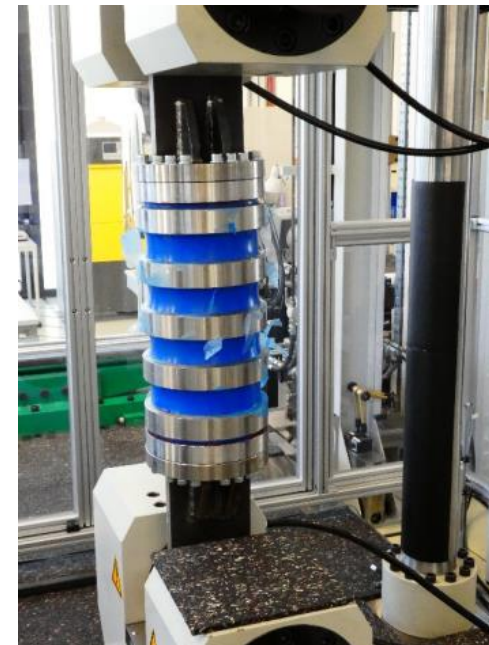
4. Side Flow Simulation (Hot tap tee passage)

FAT – MFL SIDE FLOW TEST RESULTS

Side Flow Simulation (HTT Passage)

- Passage of both tools with side flow of 300 L/s water @ ~1 cm/s
 $E \propto mv^2, v_g = 2.87 \times v_w$
for 16" side port, $v_w = 2.1$ m/s, $v_g = 6$ m/s
for 6" side port, $v_w = 15$ m/s, $v_g = 43$ m/s
- Acceptance criteria:
 - The foreseen acceptance criterion is two consecutive instrument passages without functional damage.
- Results:
 - Two sensors at the 12:00 position found to be "clicked into" a gap underneath the magnets.
 - Consequence during actual run would be loss of these two sensors

ROSEN determined this as a design flaw and re-positioned the sensor ring to eliminate this problem. Subsequent test proved this design to be optimal.
