# Inspection methodologies and tradeoffs for inspection of unpiggable pipelines

Dan Revelle

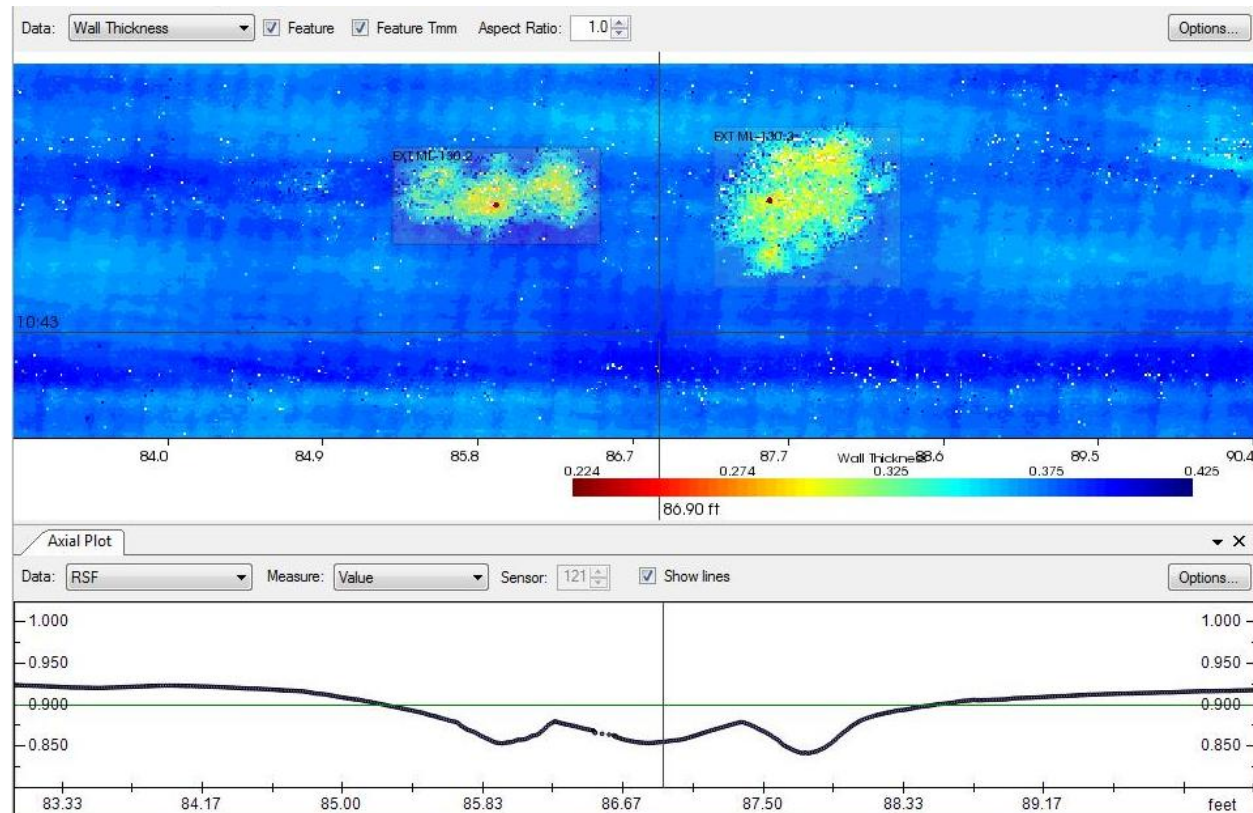
- Effective area calculation quantifies load carrying capacity of the specific section of pipe.
- Interaction between defects is calculated according to the individual profile of all defects involved.

- Better comparison between runs to get corrosion rates.
  - Not just mapping a single point, able to look at the entire profile of an anomaly
  - Can add a variable corrosion rate to the full defect profile
- Better characterization of defects allows for greater accuracy when comparing datasets.
- Full set of thickness and radius data for all inspections allows for comparison of areas that may have been below a reporting threshold on a prior survey.

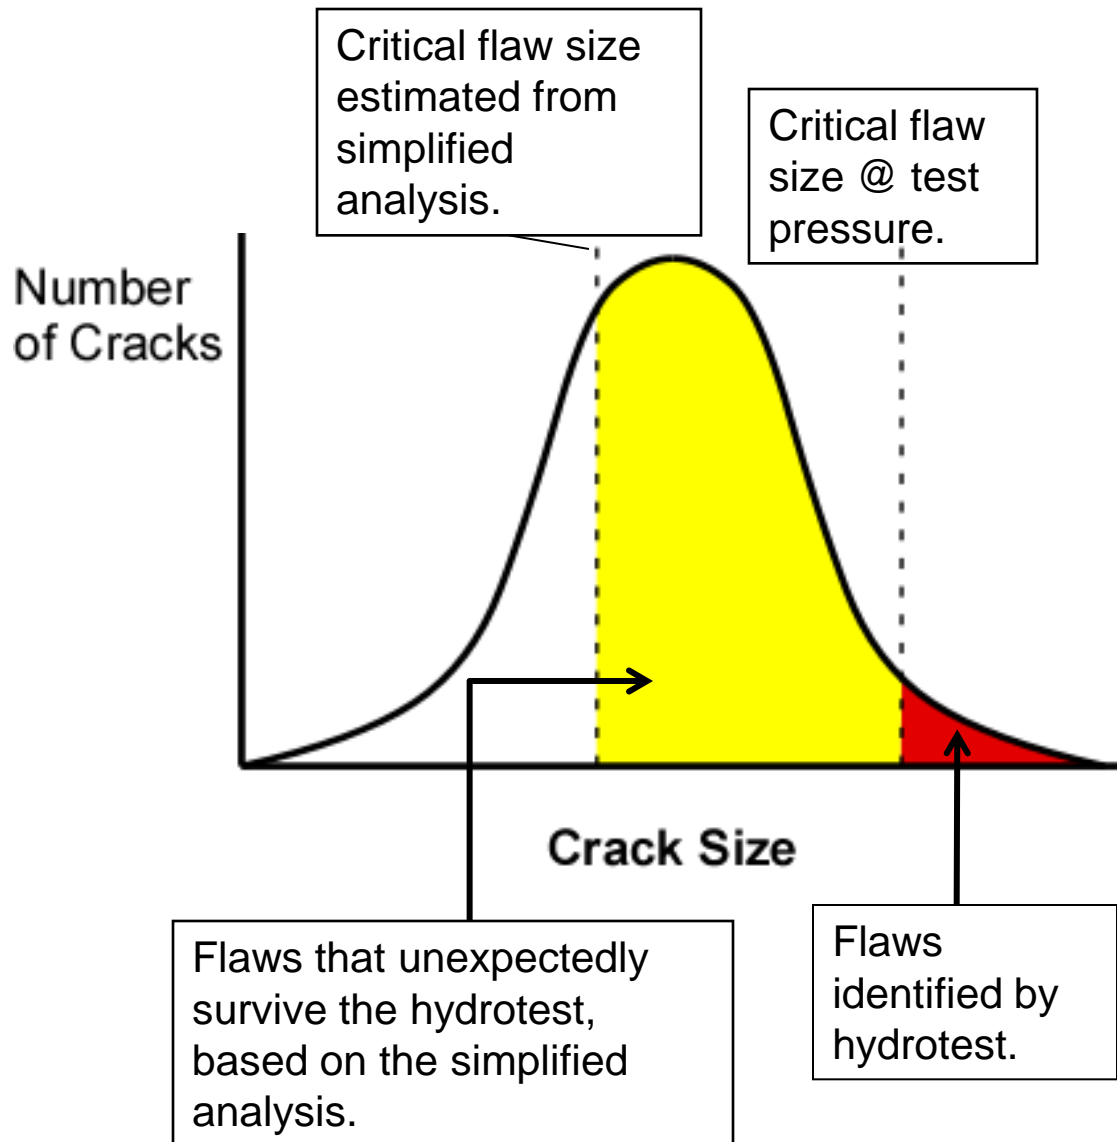
# Why is Accuracy Important?

- Hydrostatic testing has traditionally been used to “detect” cracks. A simplified fracture mechanics analysis is typically used to estimate the largest flaw that survived the test.
- However, the simplified analysis usually underestimates the critical flaw size. Thus significantly larger-than-expected flaws survive the test.

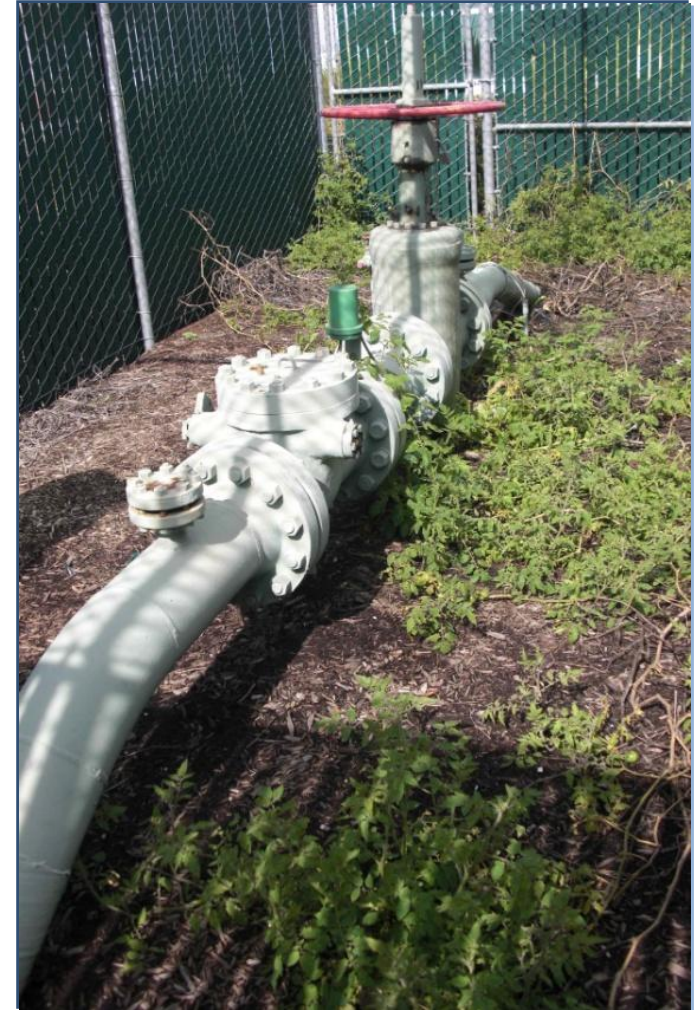
# Case Study - 1: Dual Diameter

- Dual diameter pipeline (6"/8") in a major metropolitan area.
  - Small radius bends
  - Multiple diameter changes. Need to inspect both diameters of pipe in single run
- Using frequent hydrotests to achieve regulatory compliance.
  - Only provide a snapshot of pipeline integrity
  - Not useful for dents or near through-wall failures
- Over 32 miles of pipeline.
- Desirable to inspect in product with standard operational pumps.

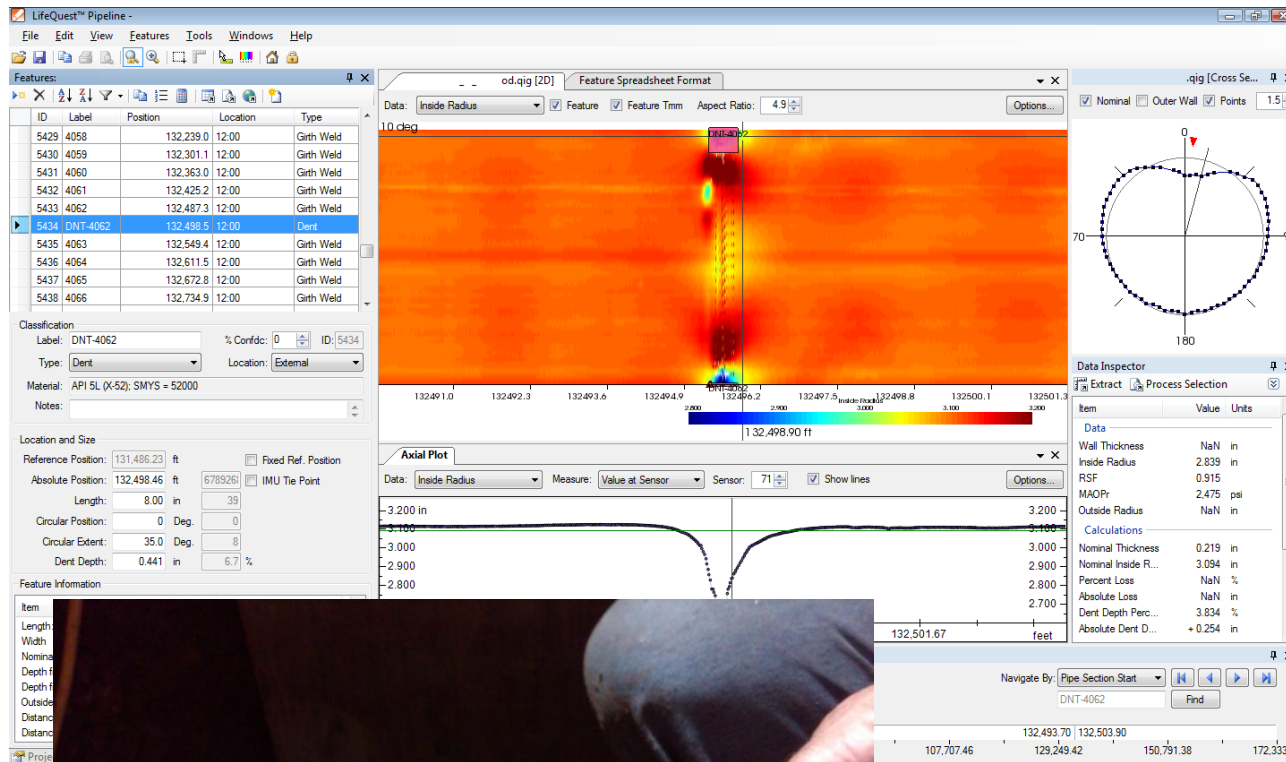
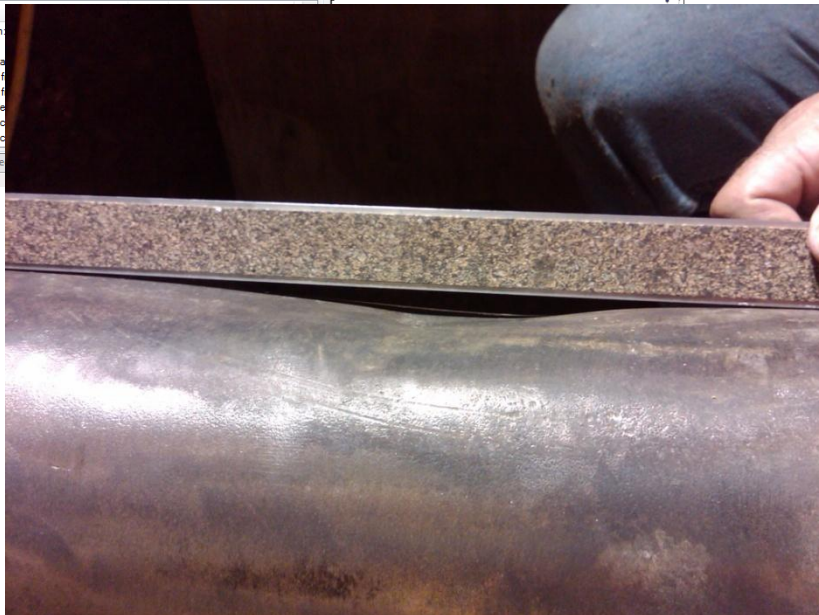
# Case Study - 1: Results

- Quest collected analyzed and performed a full Fitness-For-Service Assessment on nearly 9 GB of data
- Customized reporting to fit client requirements including piping station locations
- Critical defects such as this 6% topside dent were found that would not have been detectable by a hydrotest and could have led to a costly in-service failure

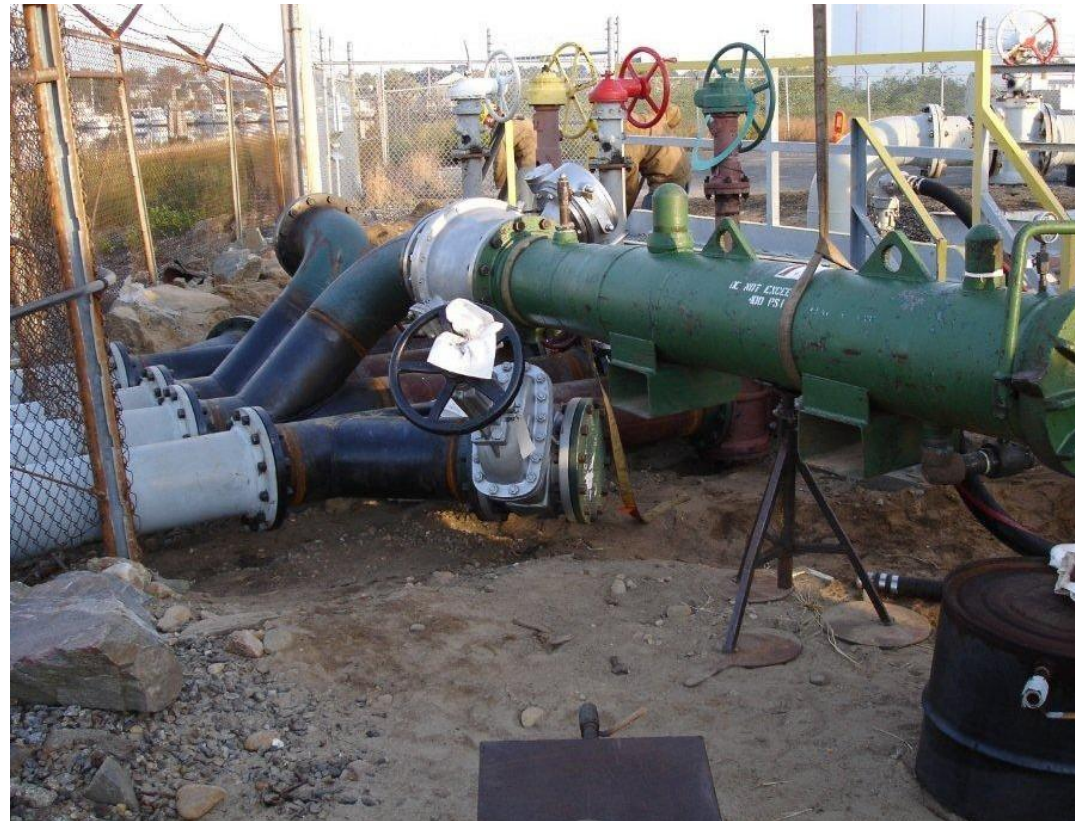
# Case Study - 2: Setup

- Greater operational flexibility.
  - Inspector and operator collaborated on overall project plan.
  - Used a single launch and receive location.
  - Used a single launch/receive barrel during the inspection of four parallel lines. Barrel was switched between lines.
  - Able to inspect more than one line per day including cleaning. Entire project completed in under one week.

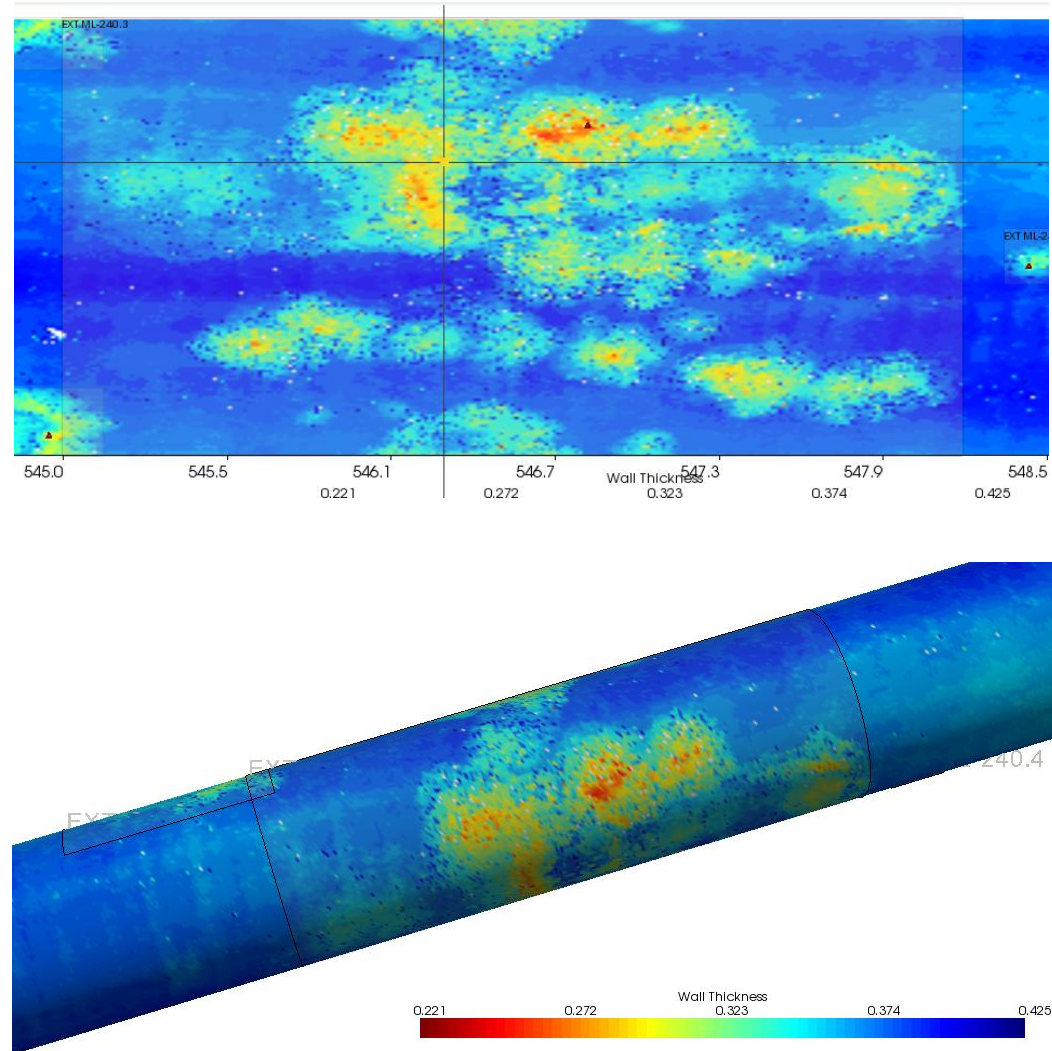
# Case Study - 2: Results

- Quantified external corrosion
- Identified defects in areas that would have been difficult to access for manual inspection
- Full Level 2 assessment done on entire line. Engineering Fitness-For-Service assessment delivered using 100% of the data
- Both Fitness-For-Service report and standard ILI spreadsheet in client format included as part of the final report.

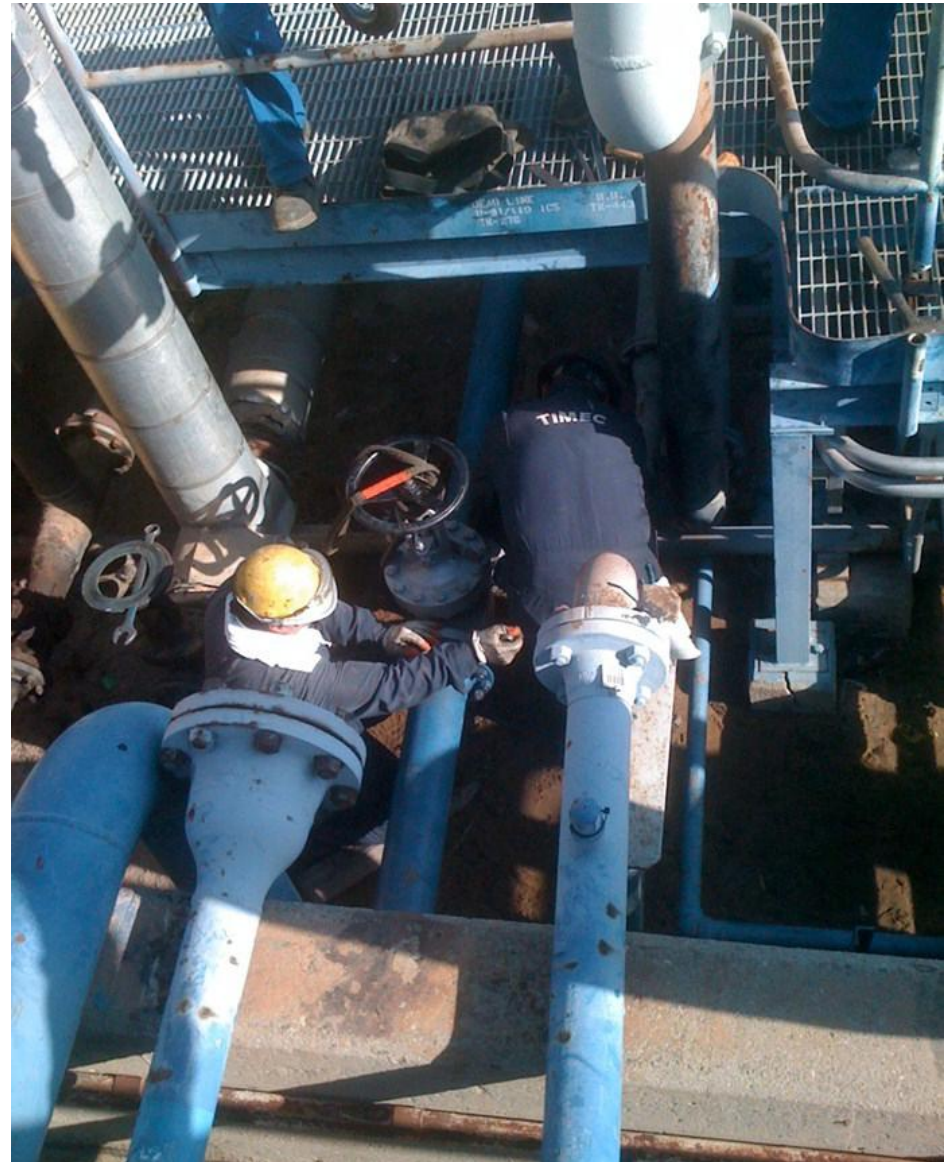
# Case Study - 3: Launch without a Launcher

- At launch point a valve was removed and tool was placed by hand into 6" nominal pipe.
- Valve was then reattached, line was filled using plant's firewater and air vented.
- InVista launched by opening the valve allowing for flow into the section of pipe into which the tool had been placed
- Total launch preparation time was about 90 minutes.

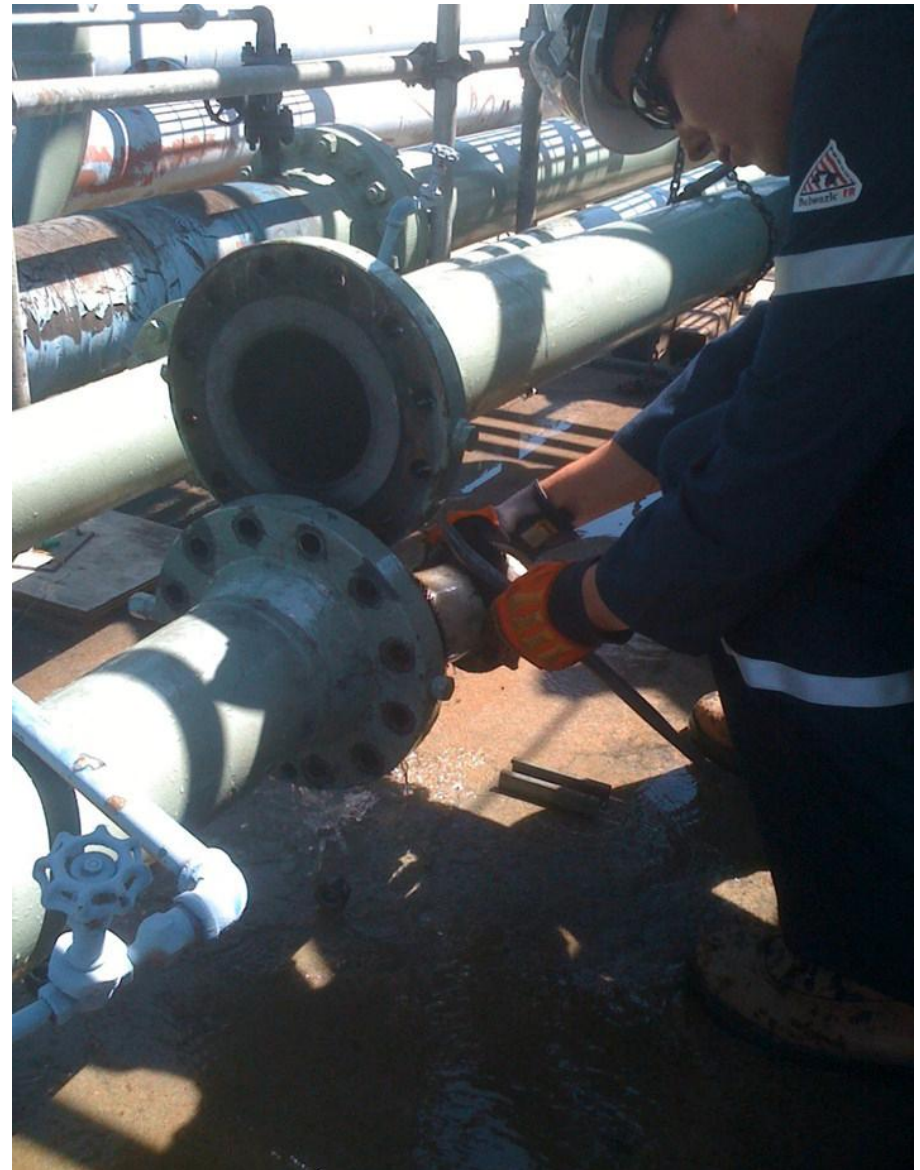
# Case Study - 3: Receive without a Receiver

- Tool was stopped at the far end of the inspection run with an orifice plate.
- Location of the tool was verified from transmitter signal.
- End portion of the line was then drained, flange was unbolted, orifice plate was removed and tool was retrieved by hand.
- Time for tool retrieval was about 15 minutes.

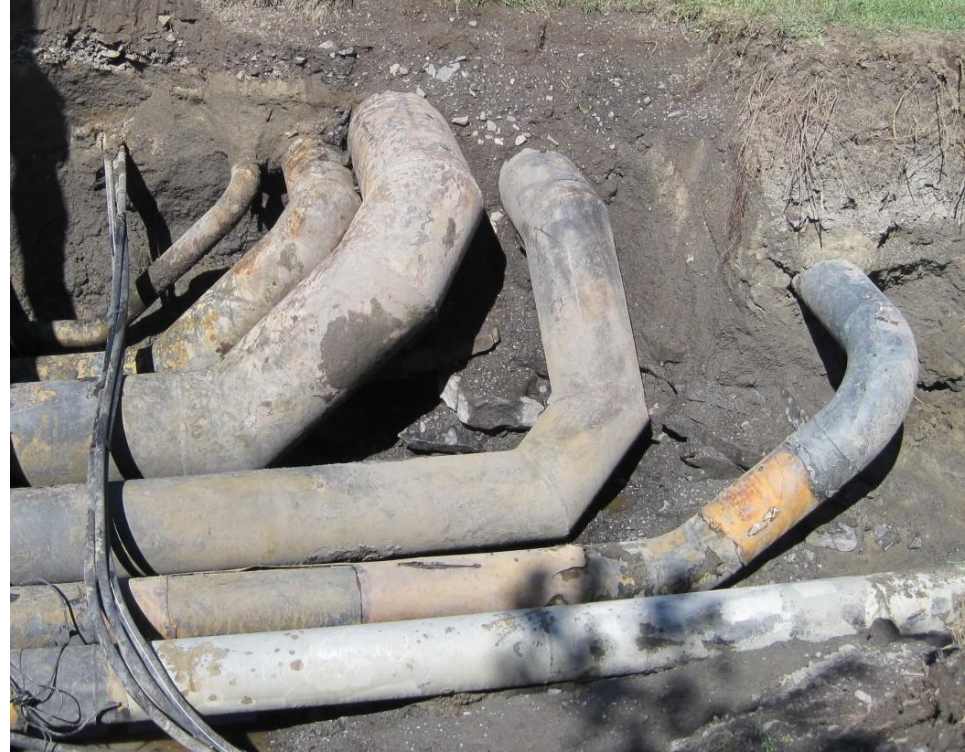
# Case Study - 4: Miter Bends

- Operator has a set of pipelines of various diameters in a large urban area.
- Pipelines contain miter bends.
- Bidirectional inspection tool gave the operator confidence in probability for success

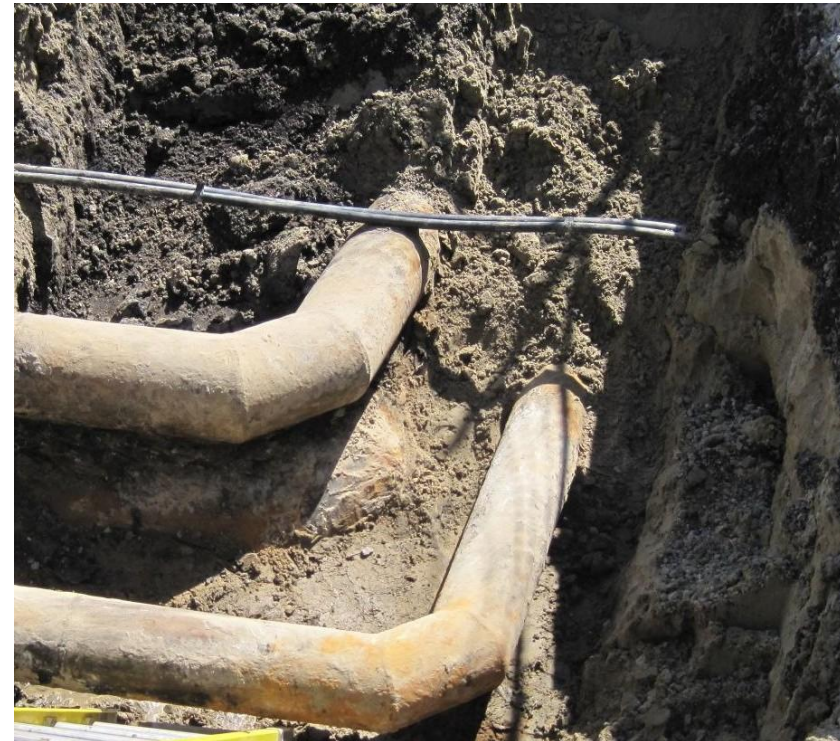
# Case Study - 4: Miter Bends

- Quest was able to rapidly mobilize, inspect and report on target lines.
- InVista successfully navigated and inspected all sections of the pipeline, including portions that cleaning pigs had difficulty in navigating.
