Isolation plug and ESDV assurance

The scope

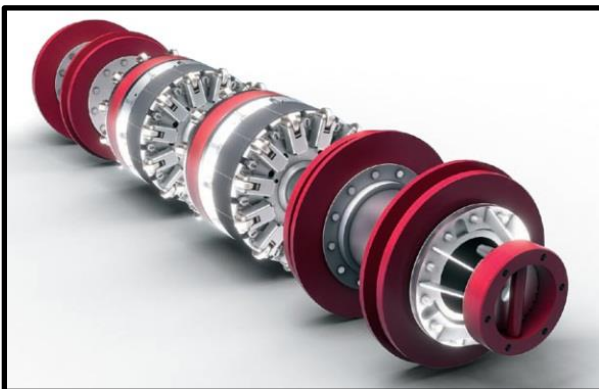
TDW SmartPlug™

When the system set-up does not allow for the required level of isolation, isolation plugs can be deployed into the pipeline, rather than the potentially costly option of depressurising the system. However, using isolation plugs comes with a level of risk that needs to be minimised. We were able to offer support to BP focussing on minimising risk by thoroughly reviewing the isolation tool design, operation and impact on the pipeline.

We also supported BP with the development of a testing methodology to prove that the isolation plug could be set in the proposed location without affecting the material properties of the riser.
